Post-Tensioning Repairs Rules for Success

Don Kline, P.E.

Take-Aways

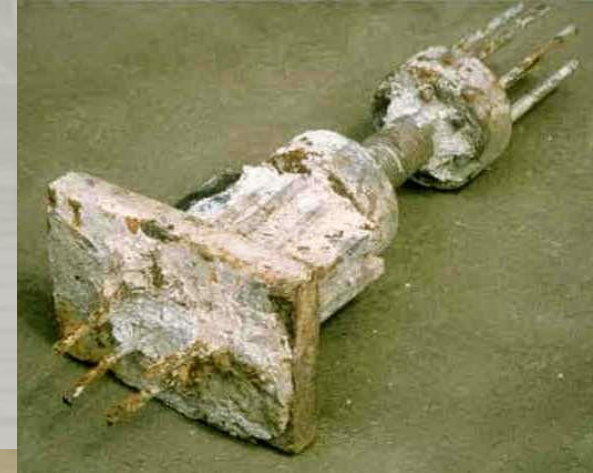
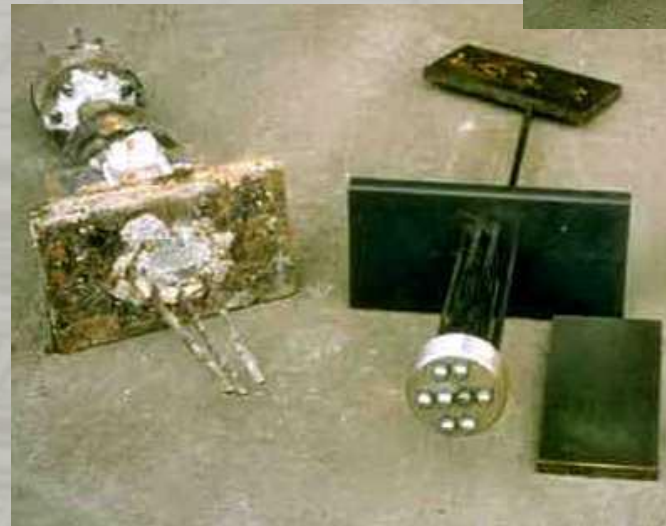
Buttonhead Wire

Issues:

- Constructability
- Safety
- Shop fabricate exact lengths
- Exposed wires
- Corrosion

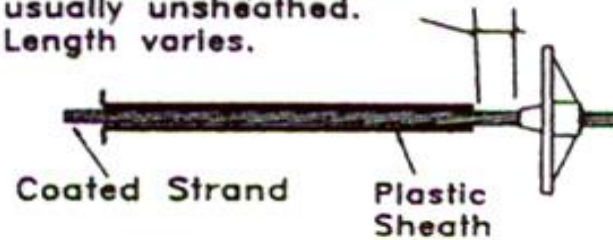
Paper-wrapped
1955-1975+

This portion of strand
usually unsheathed.
Length varies.

Plastic Sheath
1960-Present

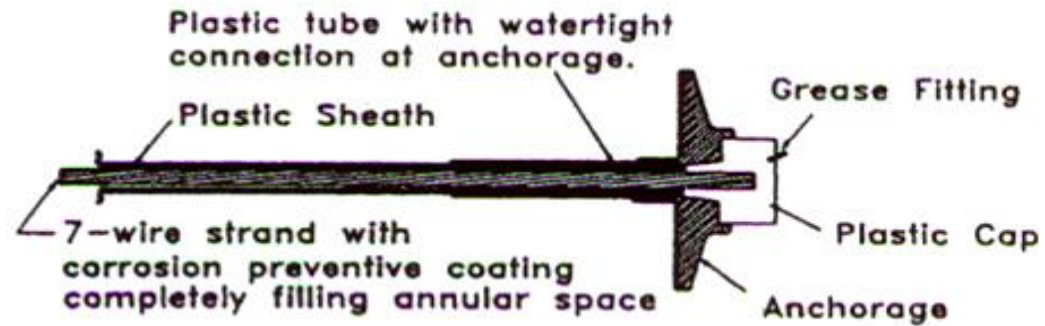
1985 PTI
Recommended
System

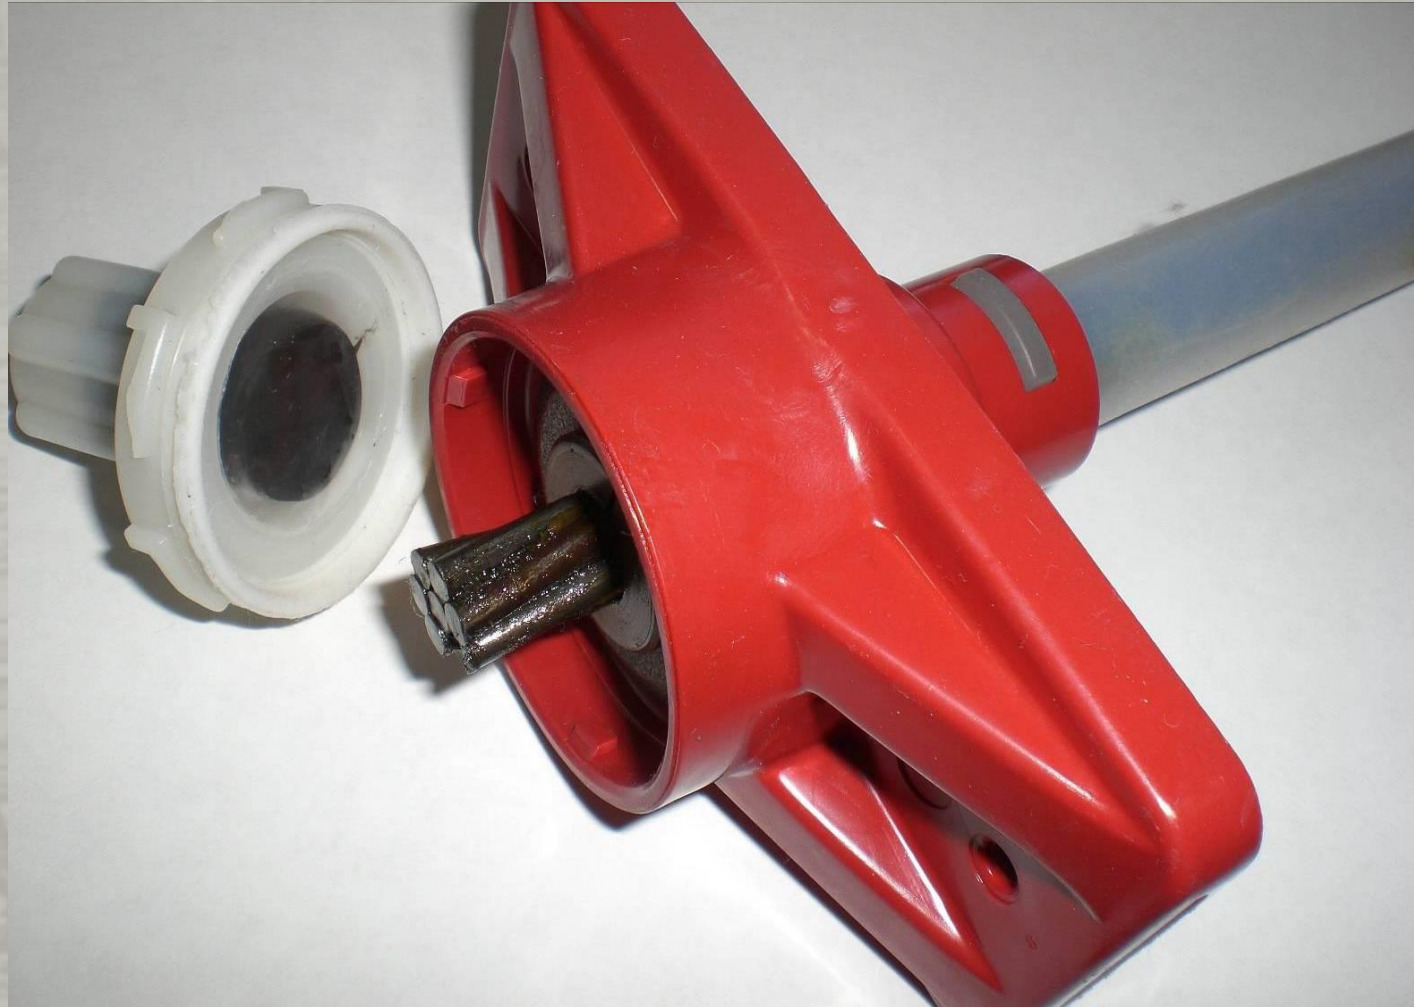
Encapsulated Tendons

Photo Courtesy of General Technologies, Inc.

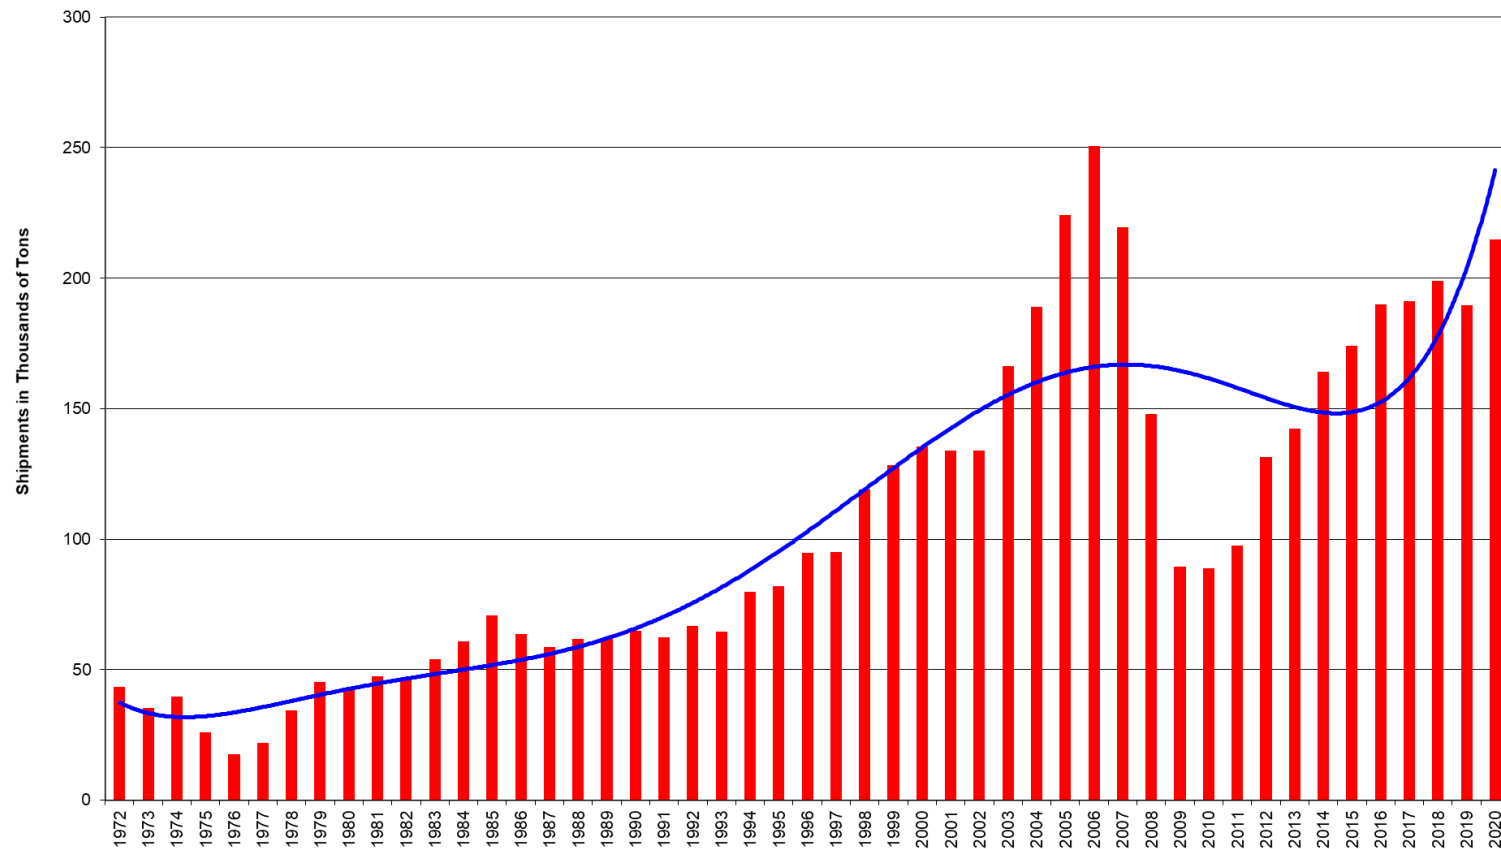
PT Industry Over 50 Years

North American Post-Tensioning Shipments

Summary for the years: 1972 to 2020

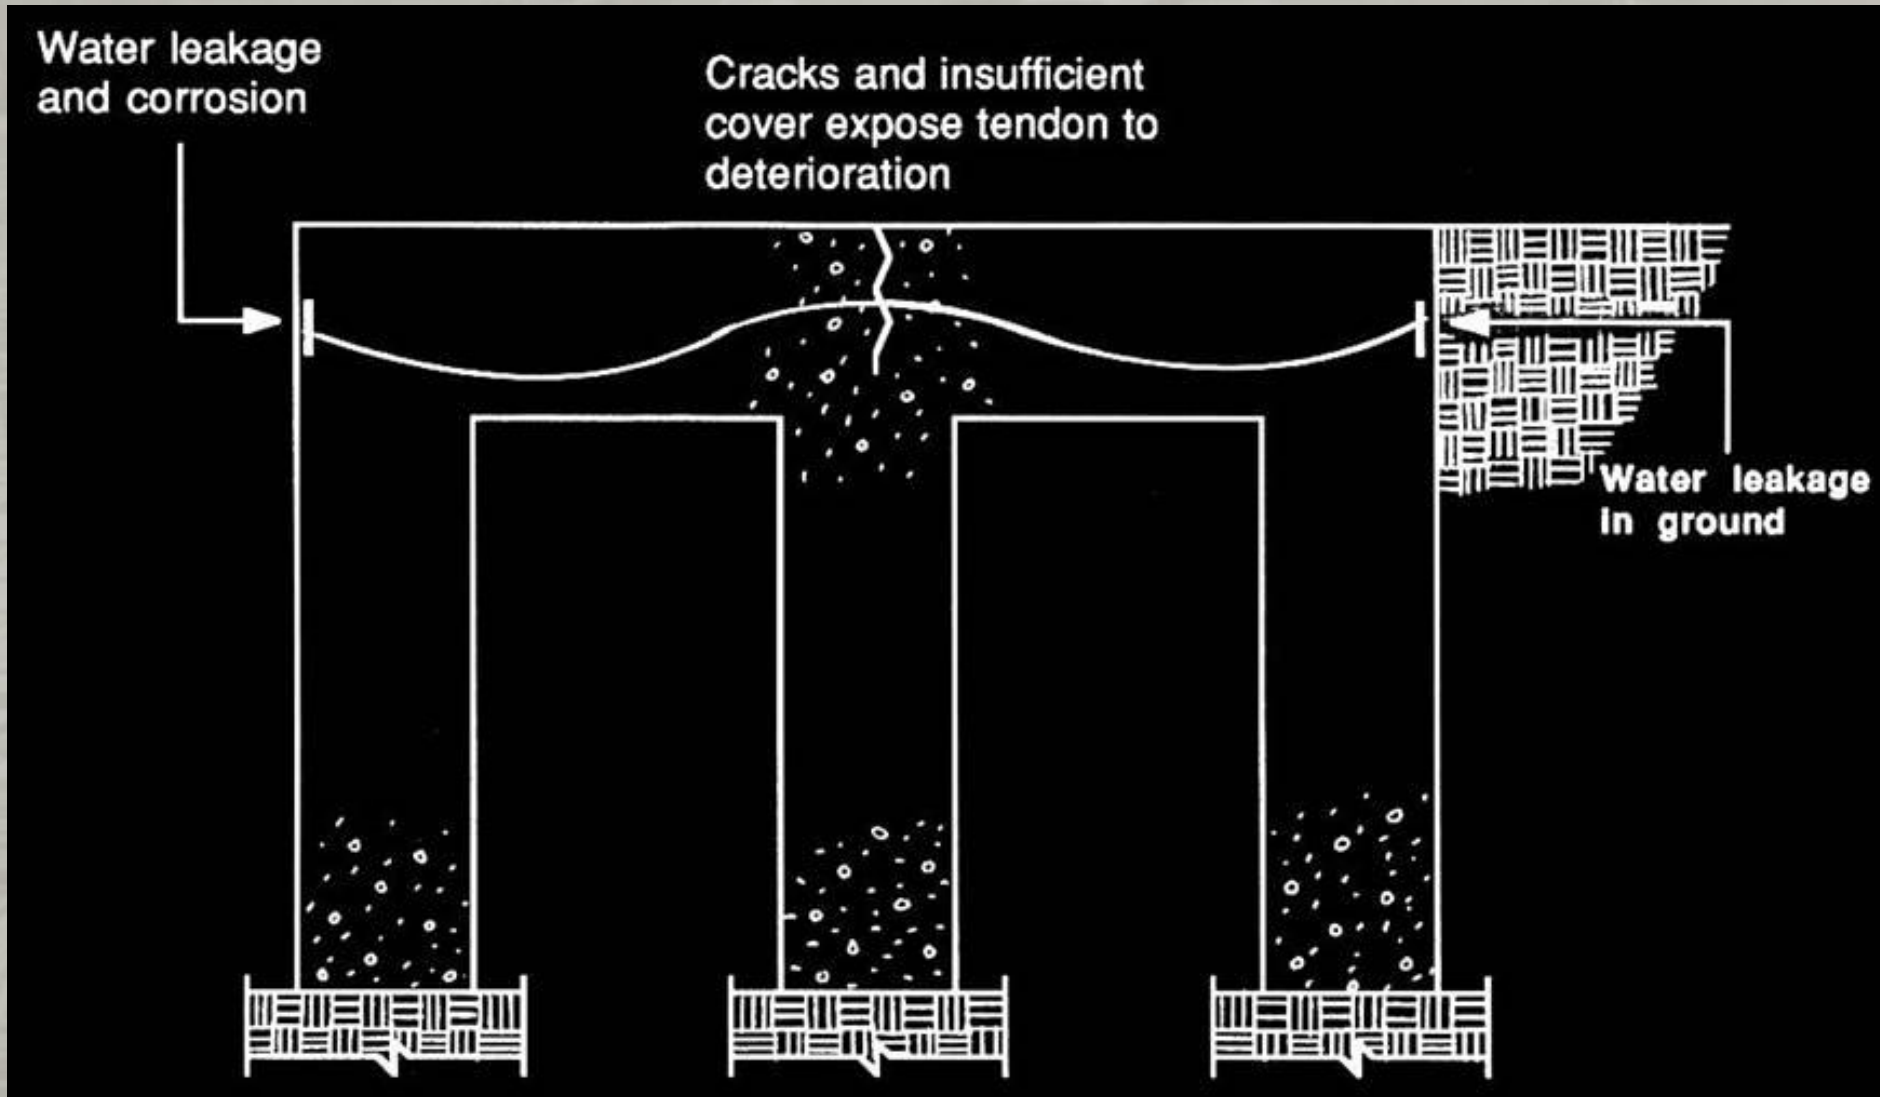
Causes of PT Tendon Failure

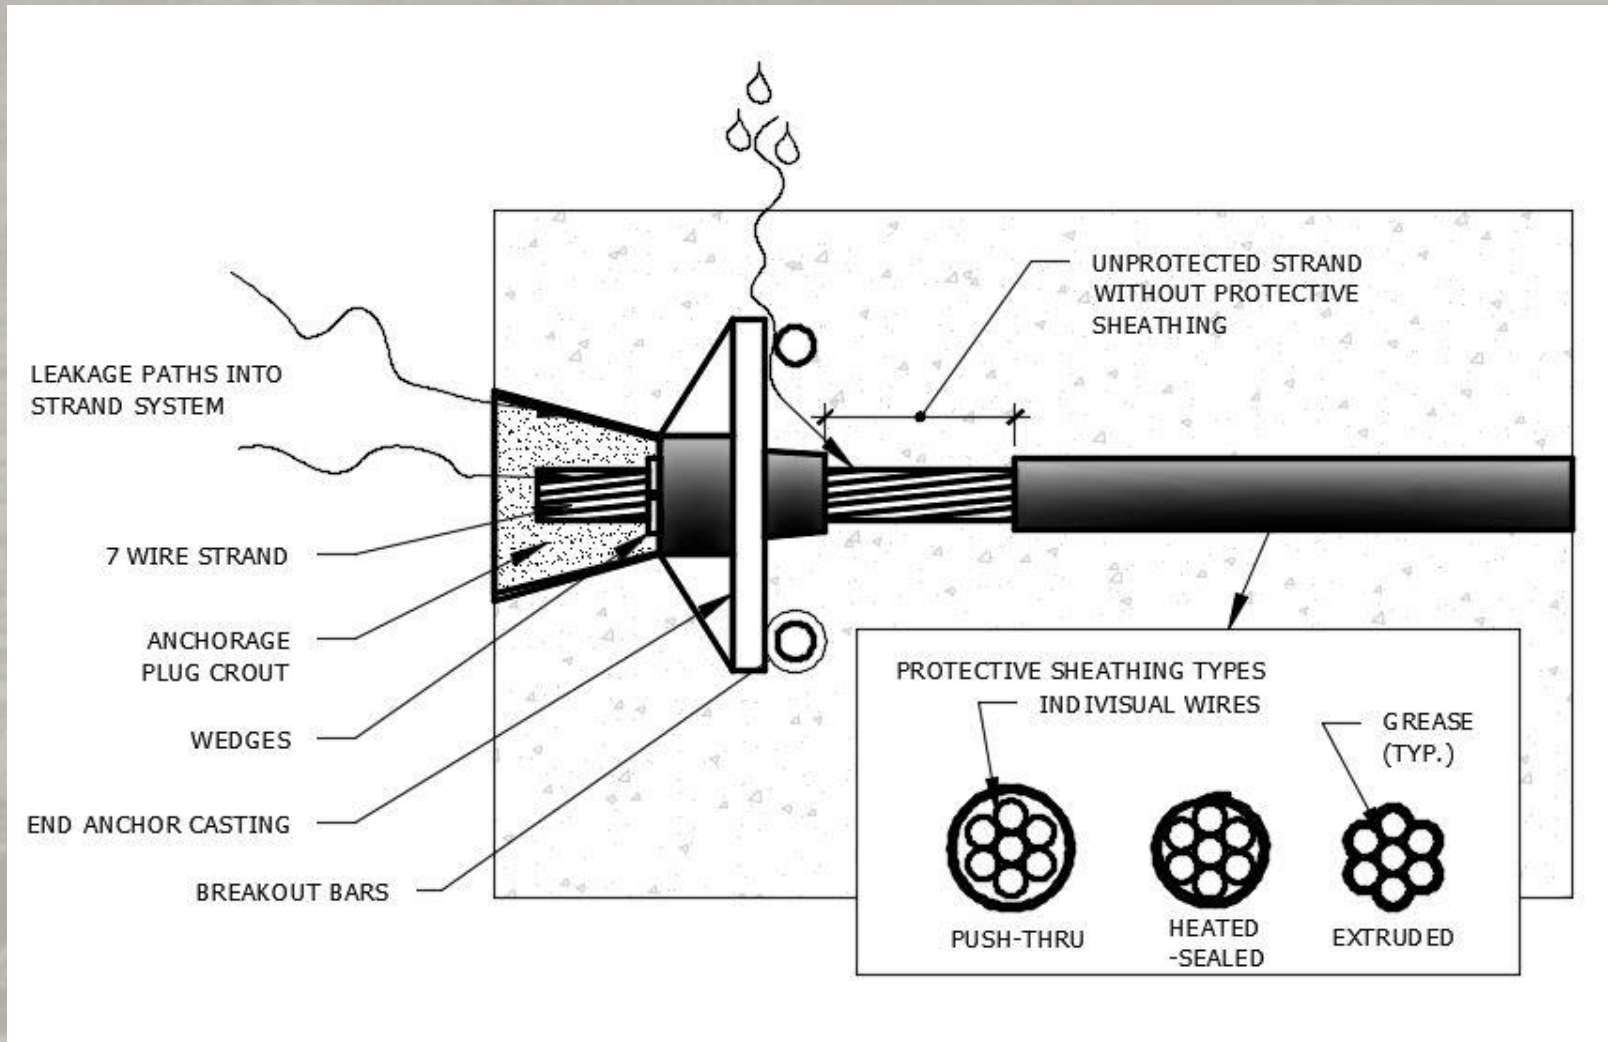
Monostrand Deterioration

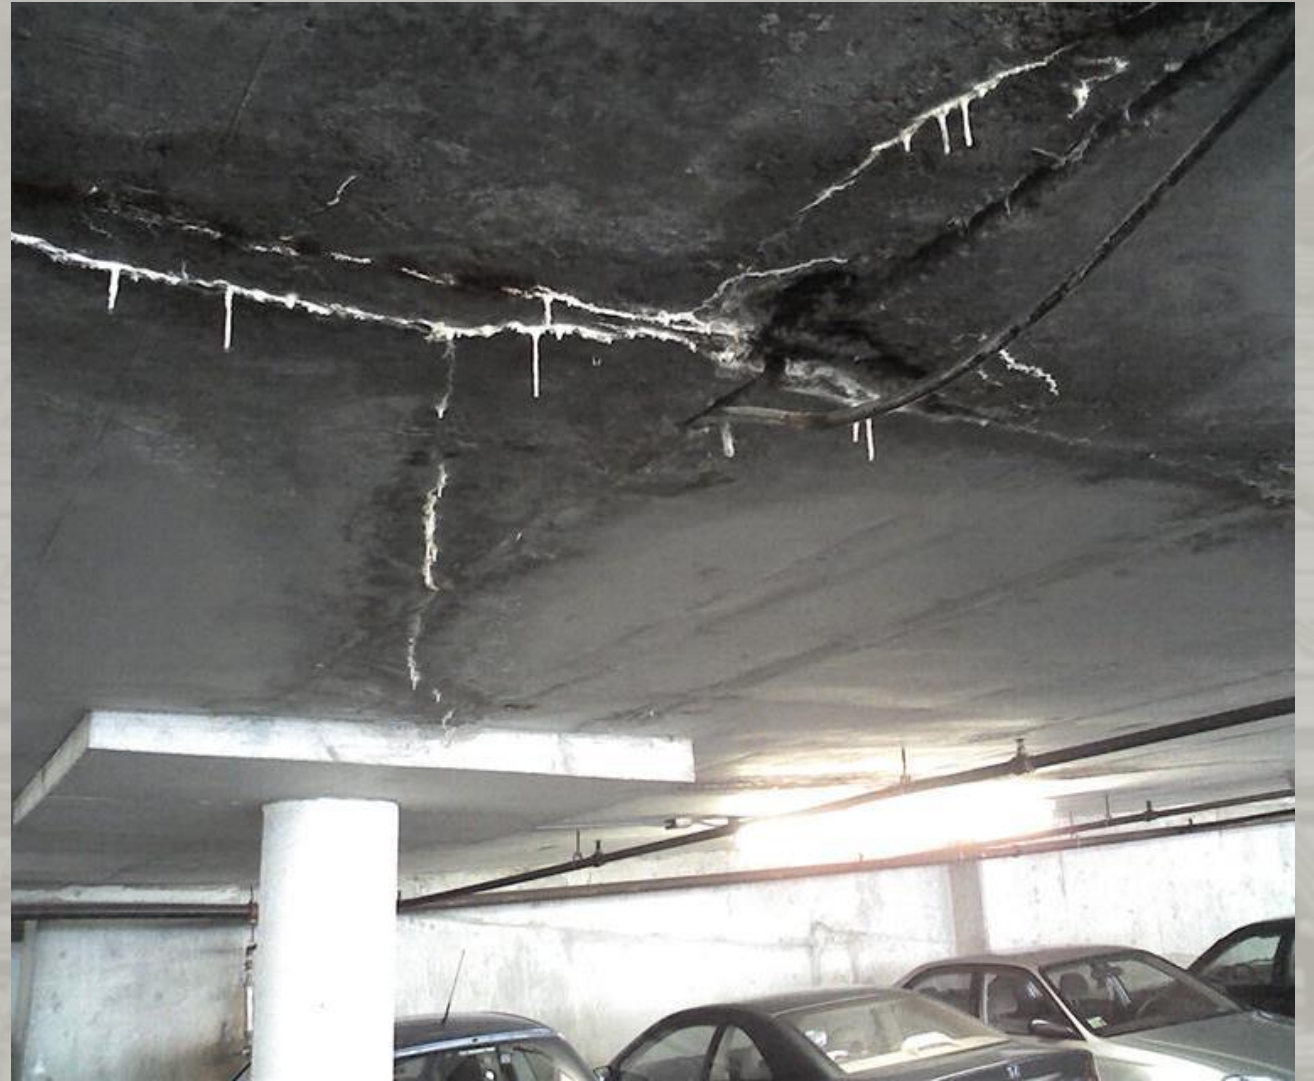
Causes of PT Tendon Failure

- Restraint Cracks Through Slab

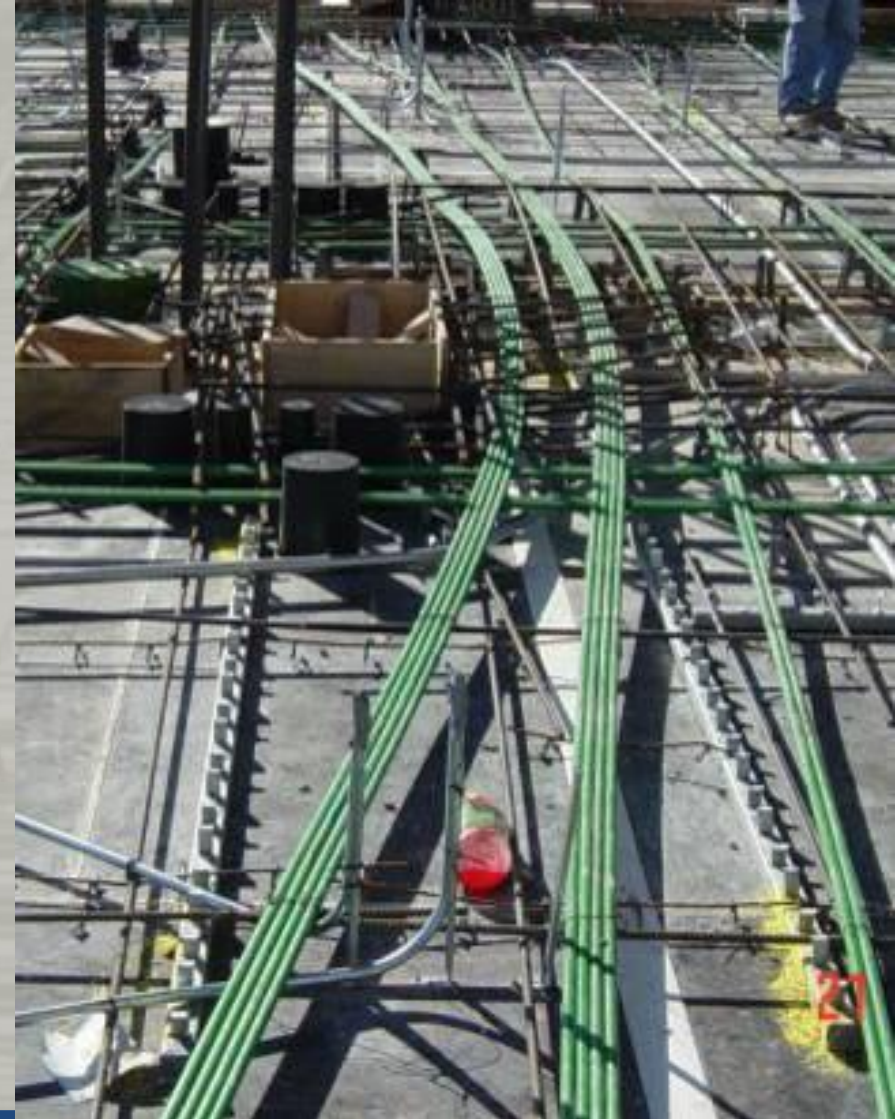
a) PLAN VIEW AT OPENINGS

b) HAIRPIN PLACEMENT FOR HORIZONTAL CURVE > 1:12

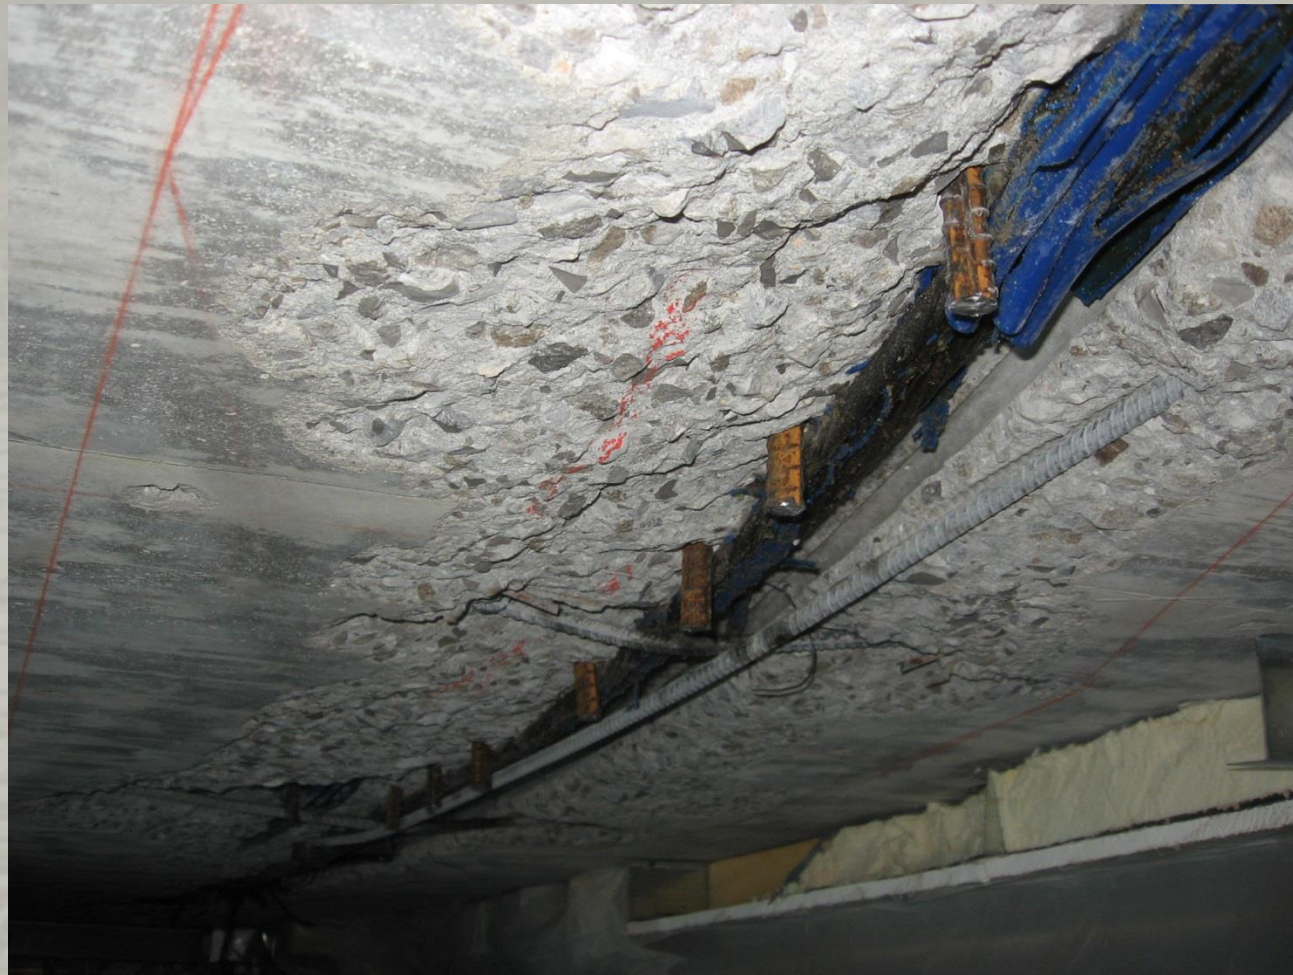
Details at Openings

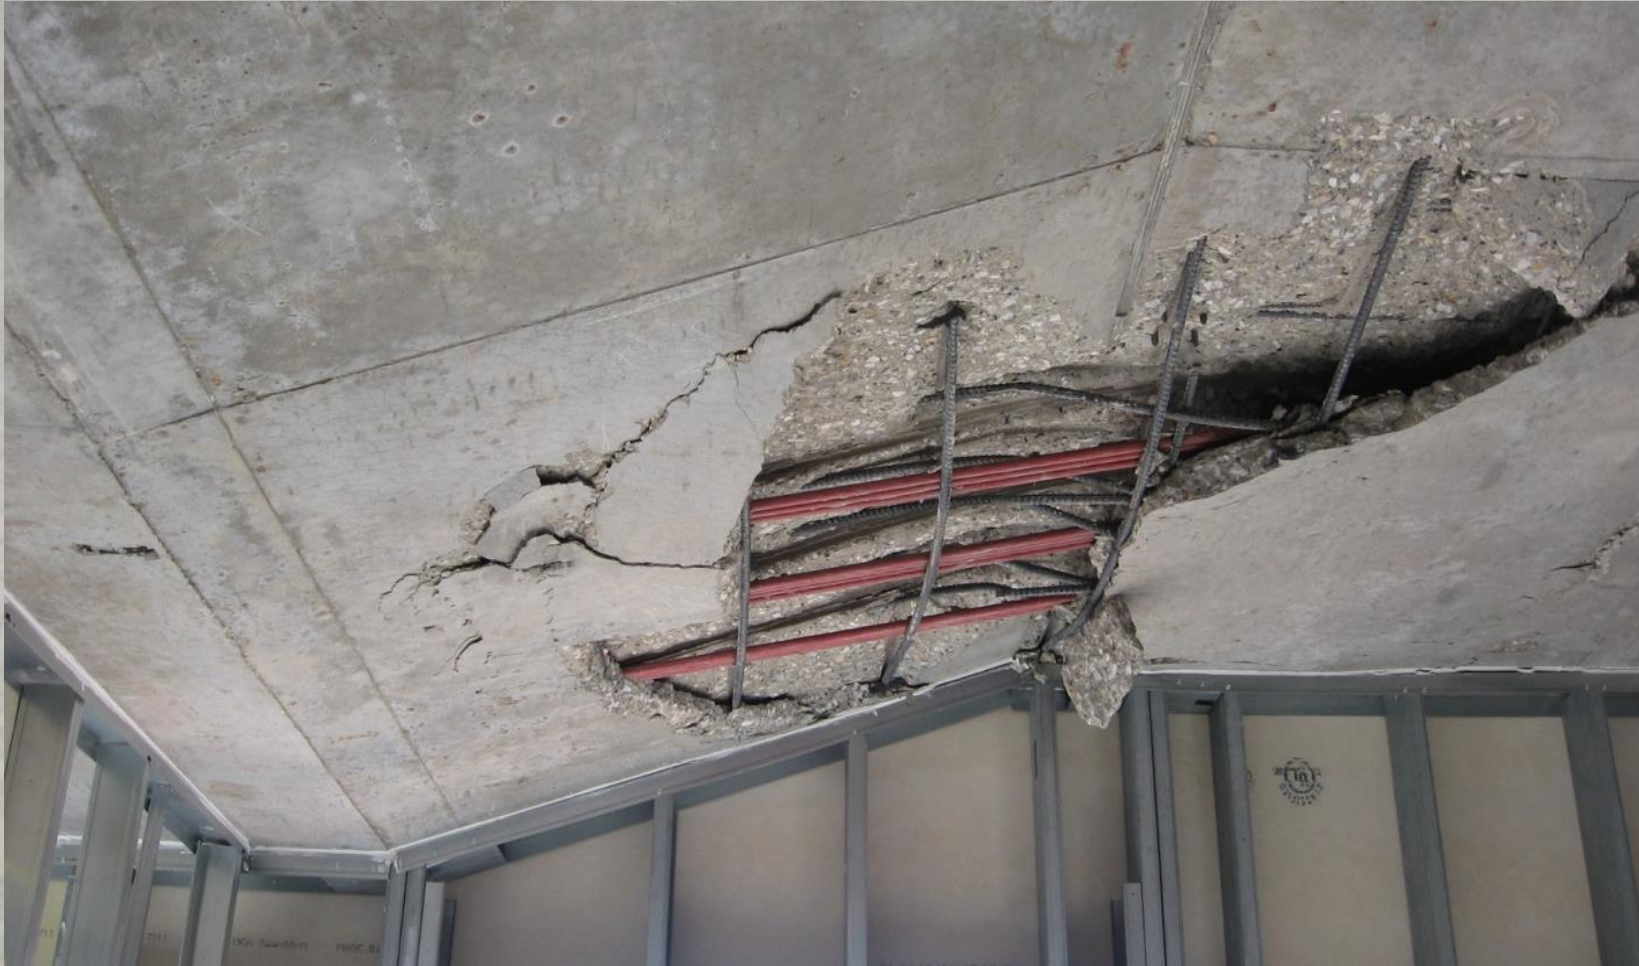
Slab Folds

Poor Detail

Preferable Detail

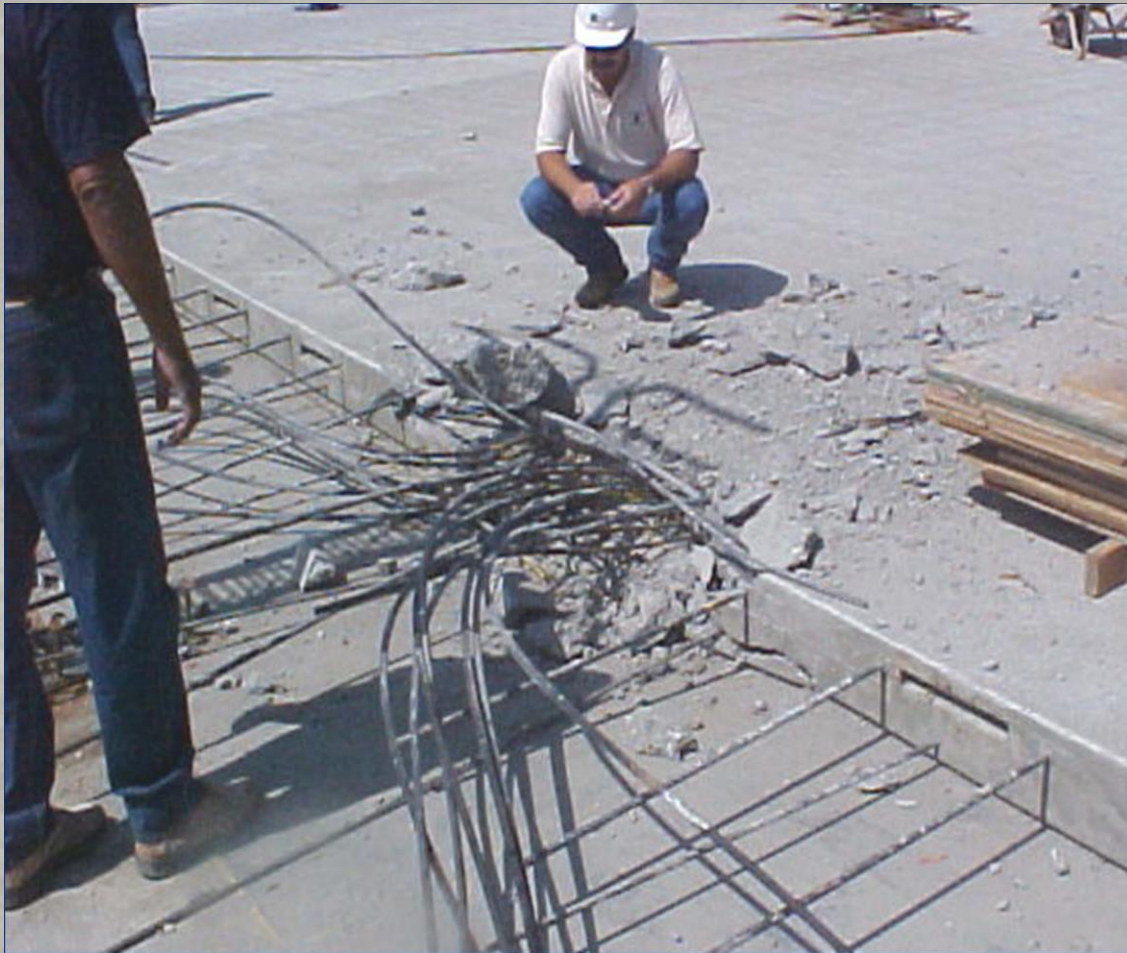
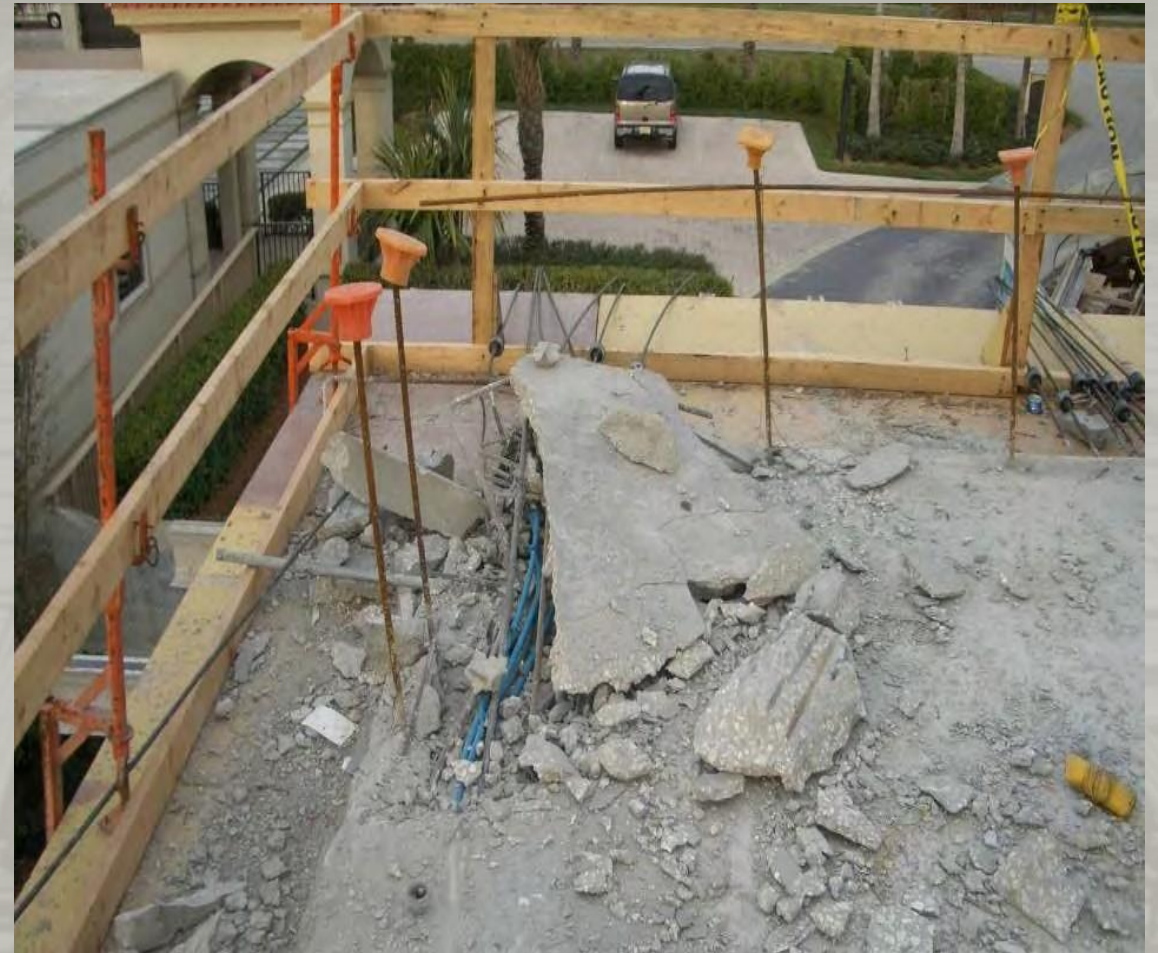
Blowout at slab fold

Anchorage Blowouts

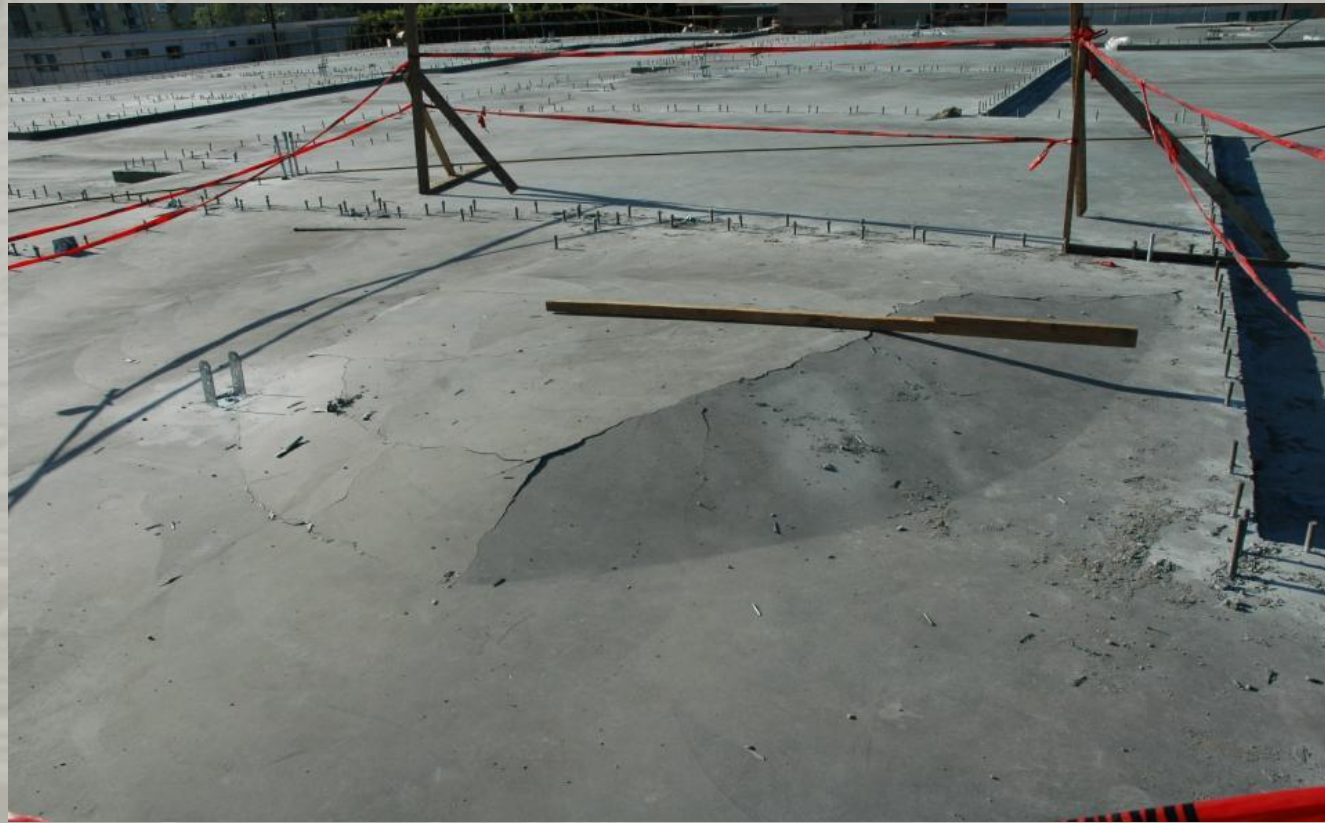
Overbalancing

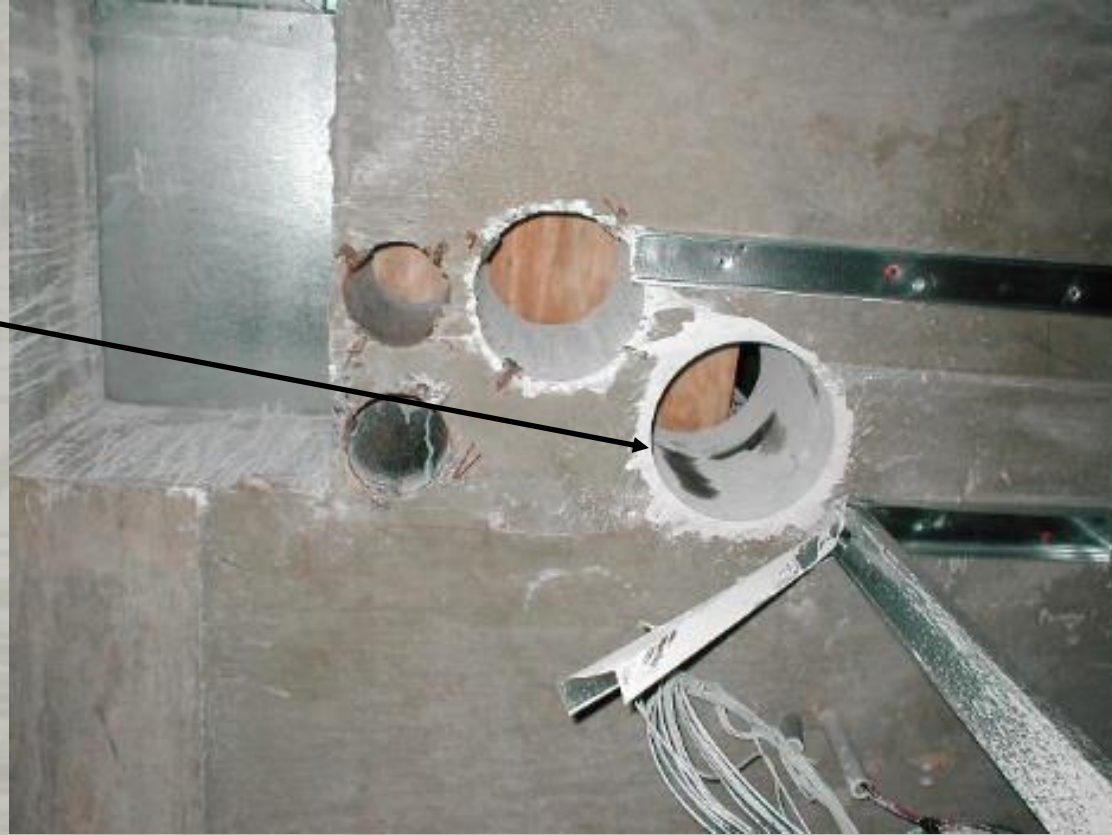
The Plumber Did It

Core Drilled Through
Tendon

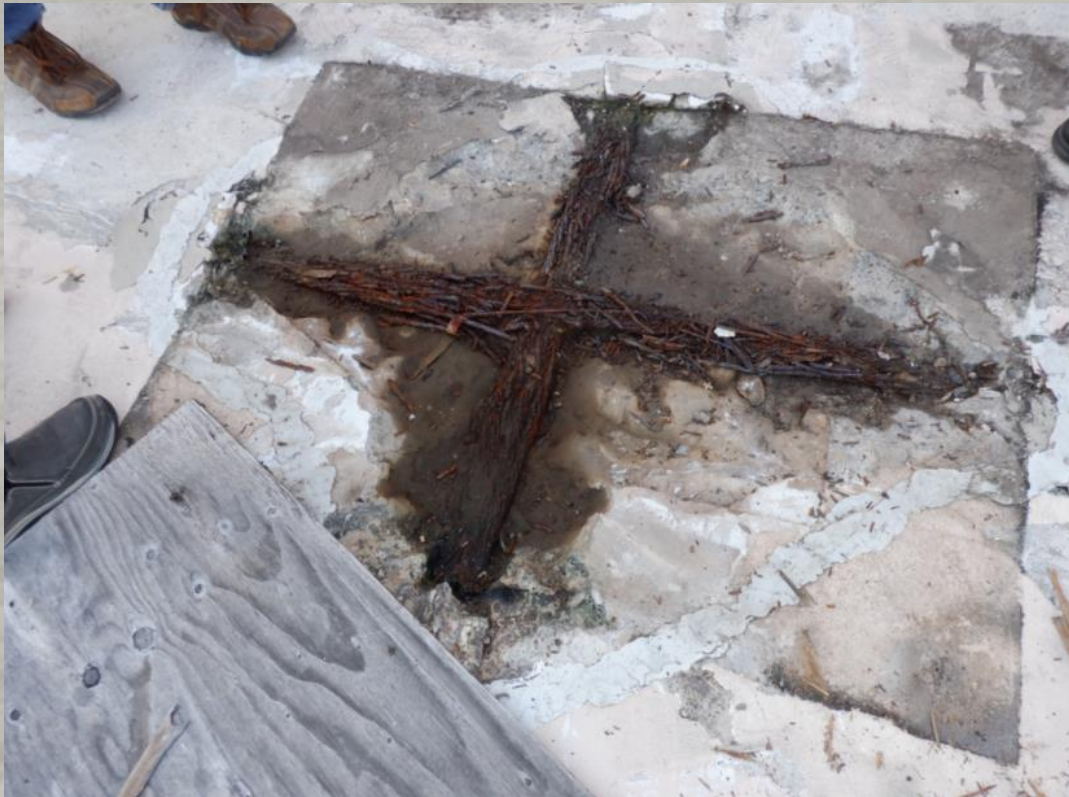
- Corroded/Failed Tendons

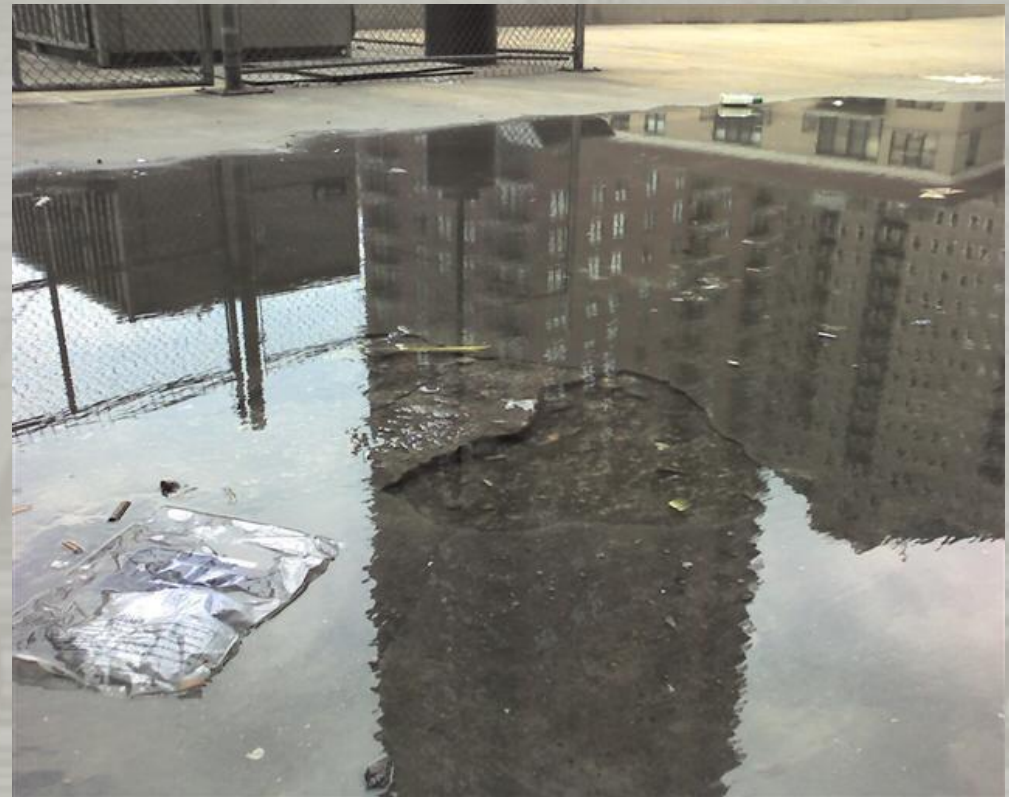
- Standing Water

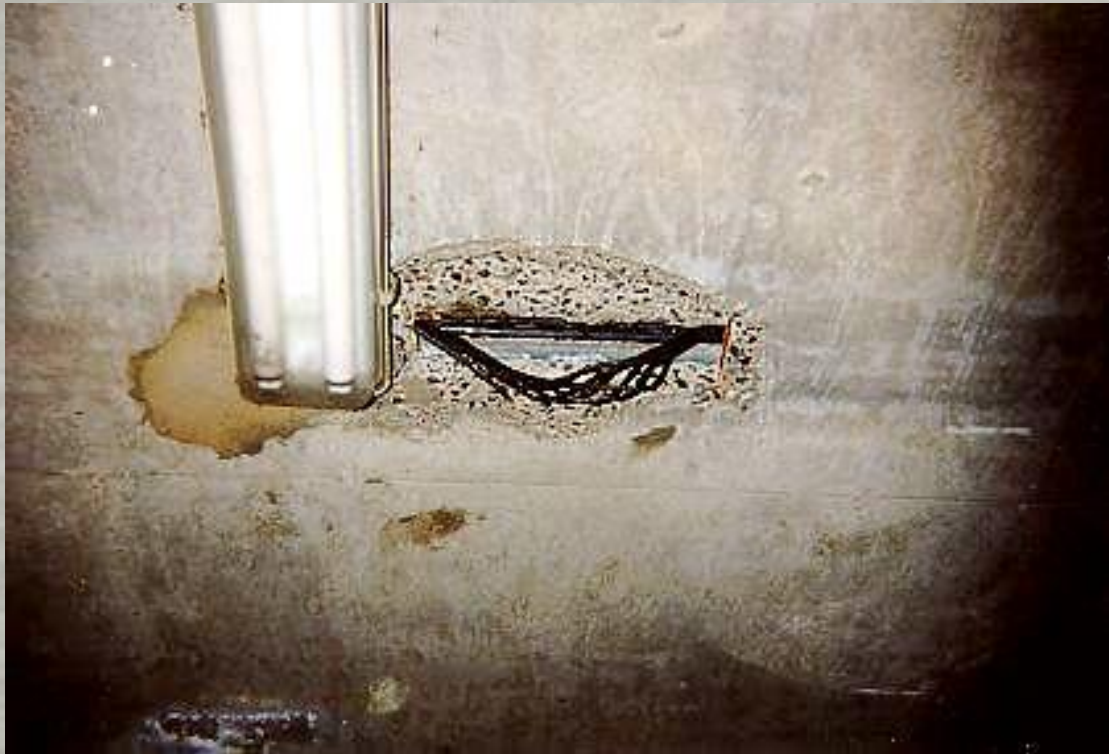
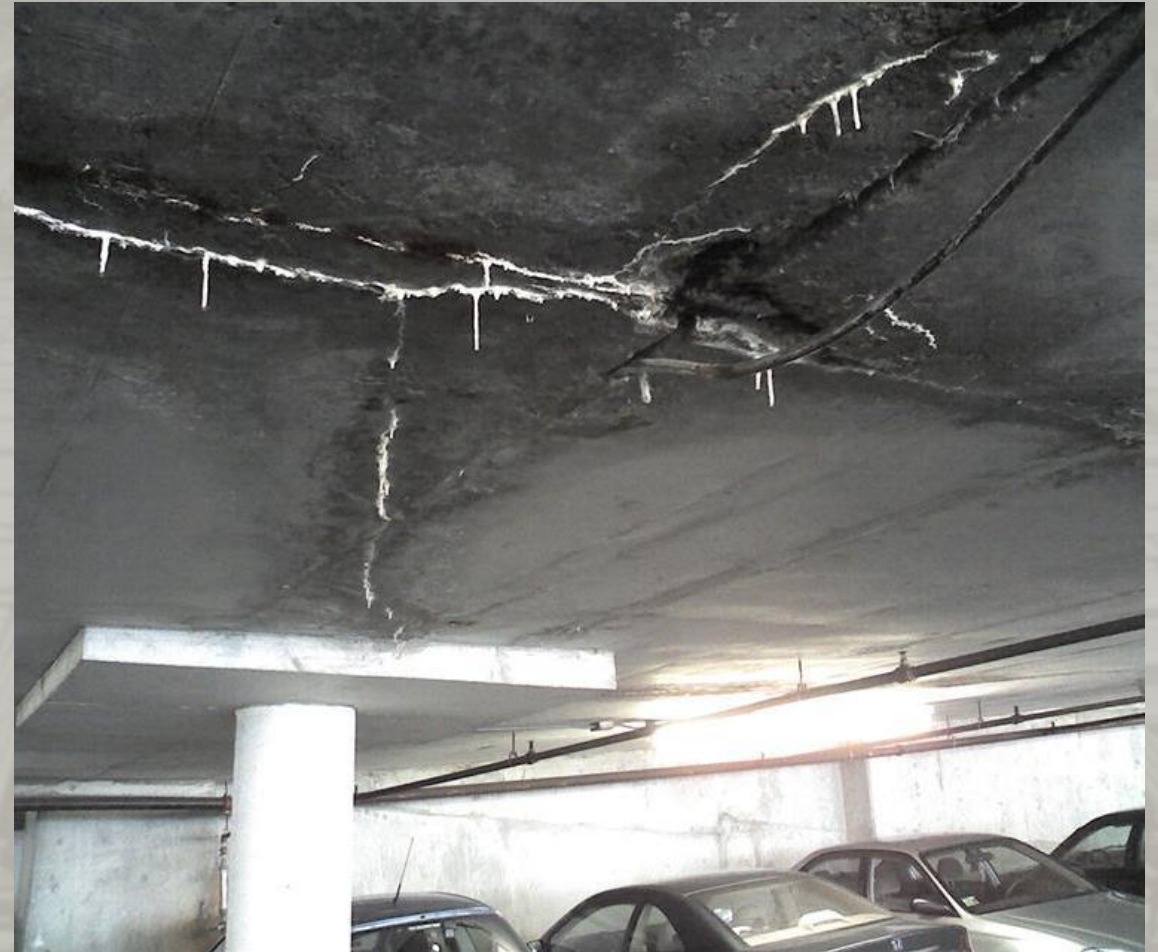
Visual/Non-Destructive Testing

- Tendon Pop-Outs
- Restraint Cracks Through Slab

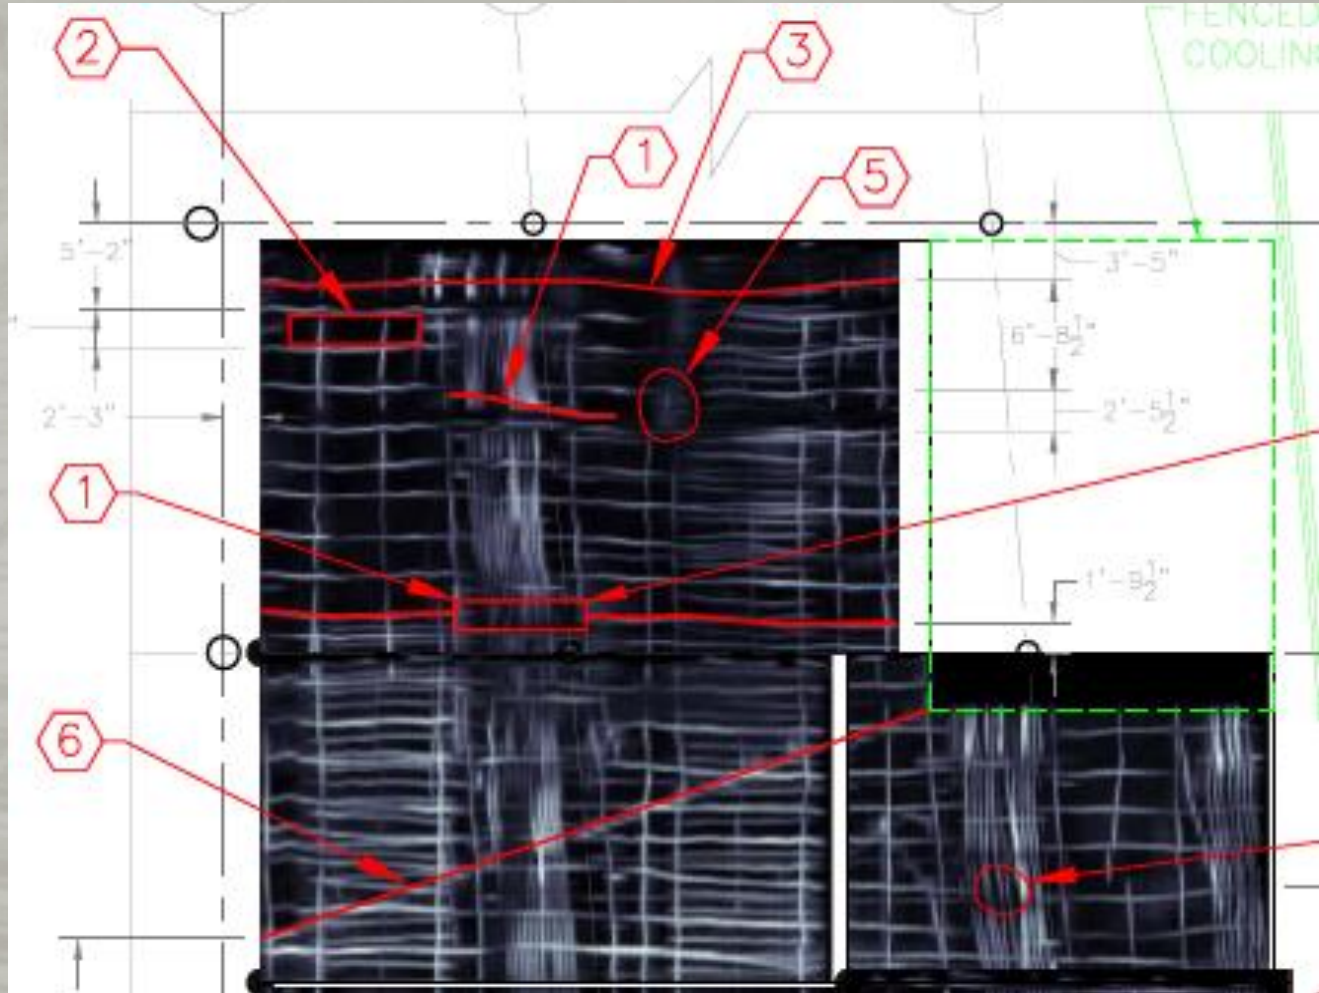
Visual/Non-Destructive Testing

- GPR/X-Ray to Determine As-Built Design
- Review As-Built Drawings
