Post-Tensioning Repairs Rules for Success

Don Kline, P.E.

Take-Aways

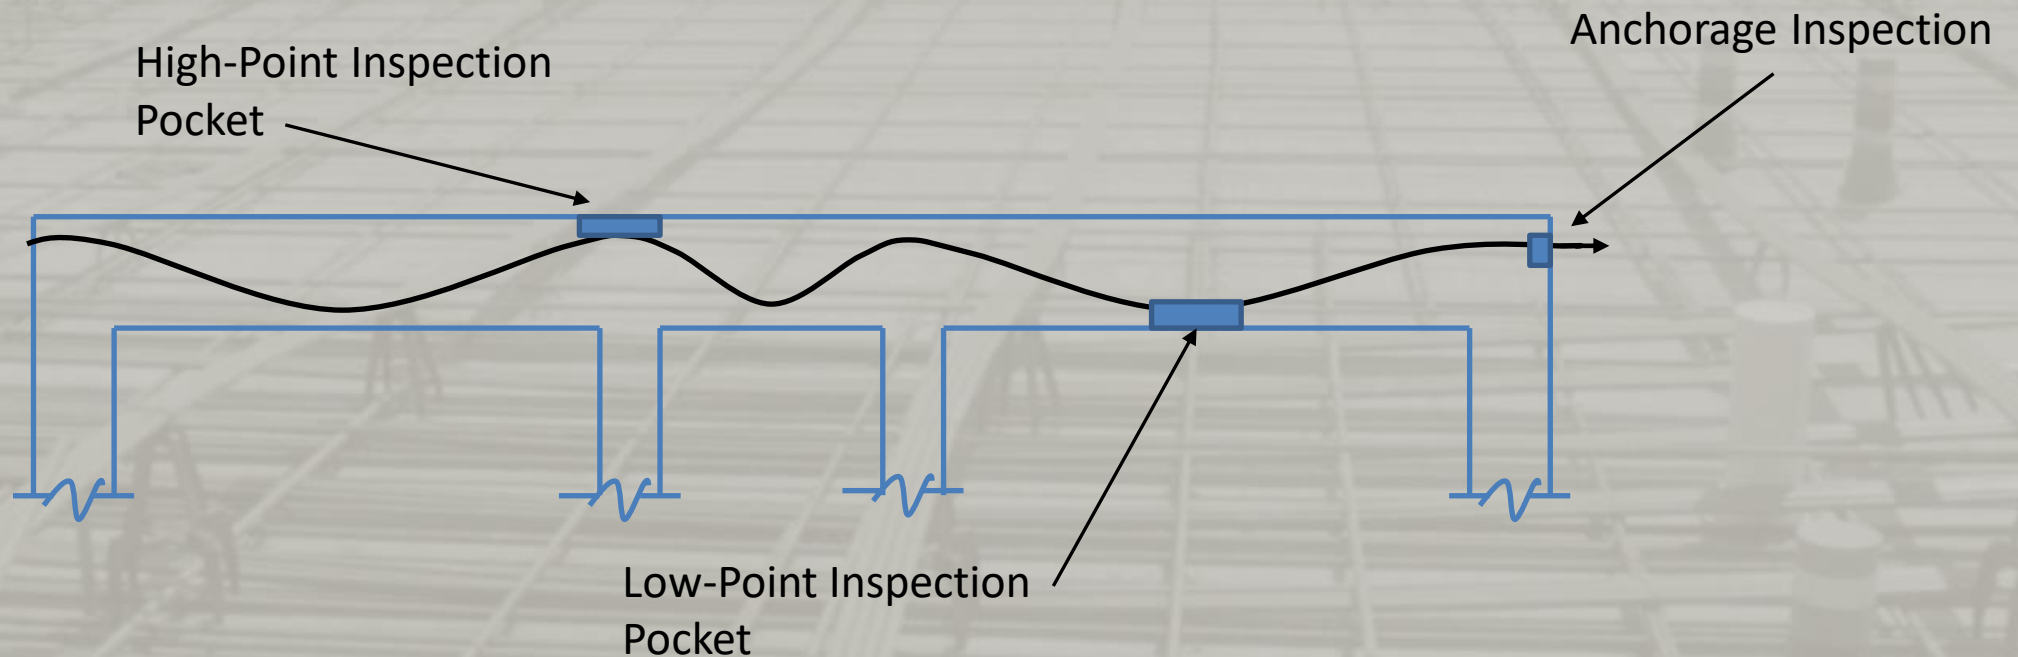
Exploratory Sampling

- Open Inspection Pockets
- Statistical Sampling – Initially inspect 5%. Increase sample size if warranted.

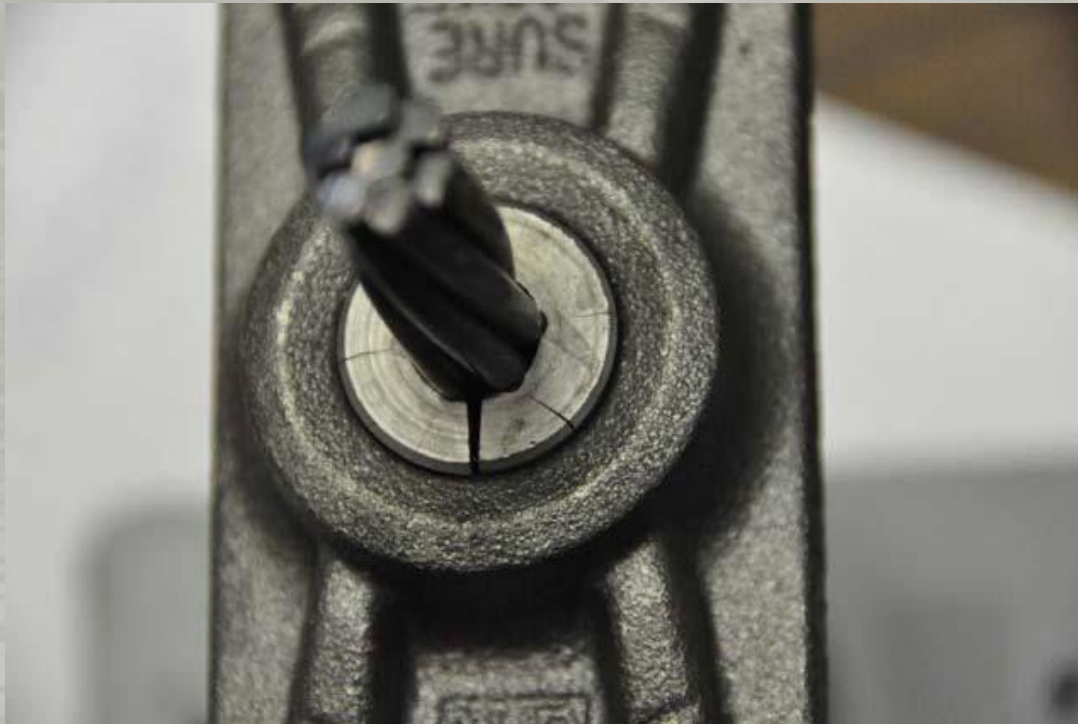
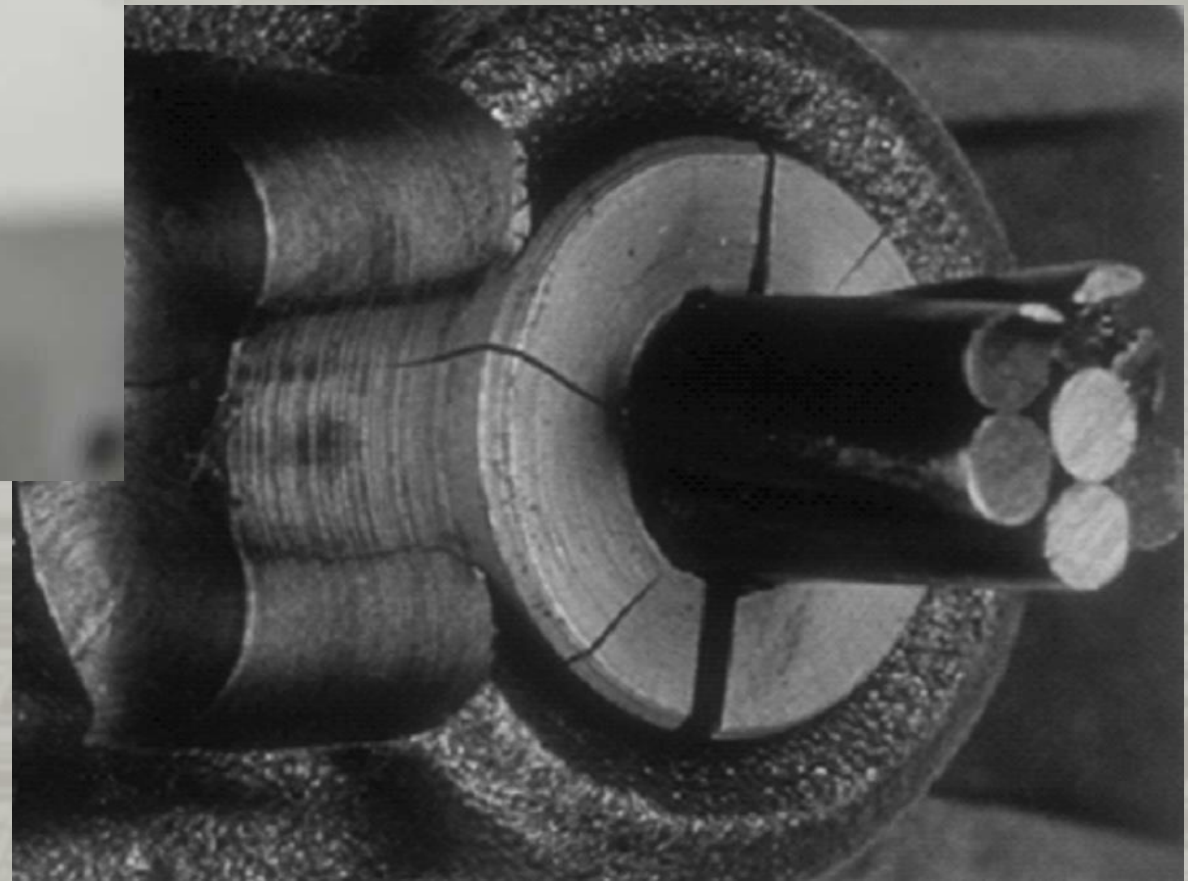
CRACKED WEDGES – Not a Problem

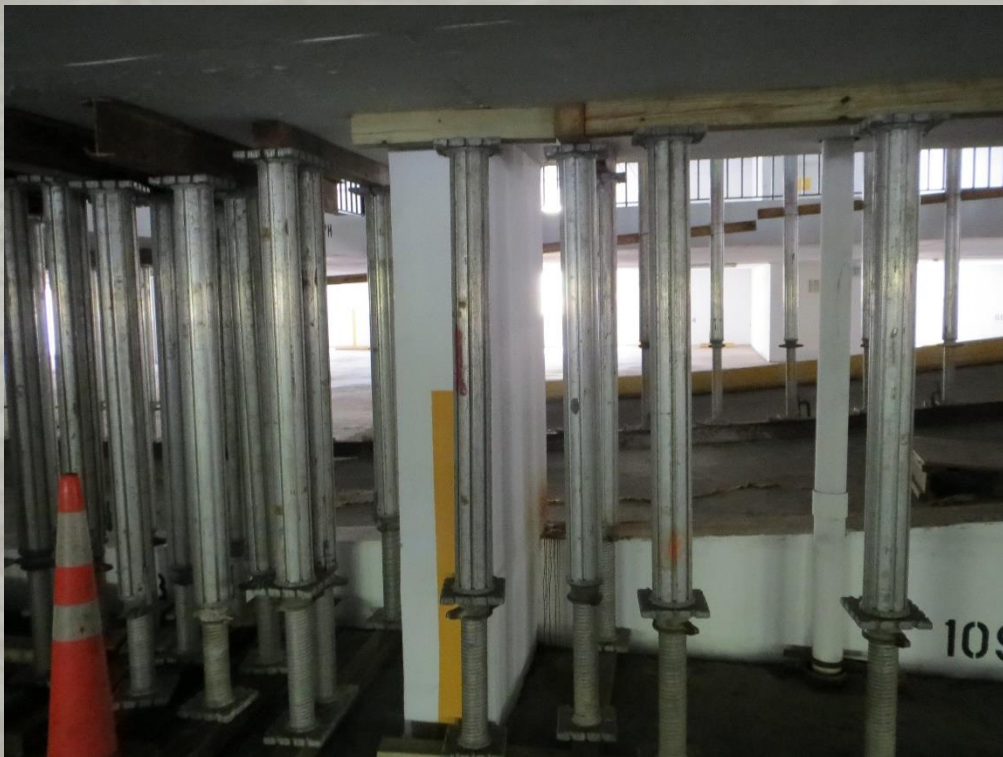
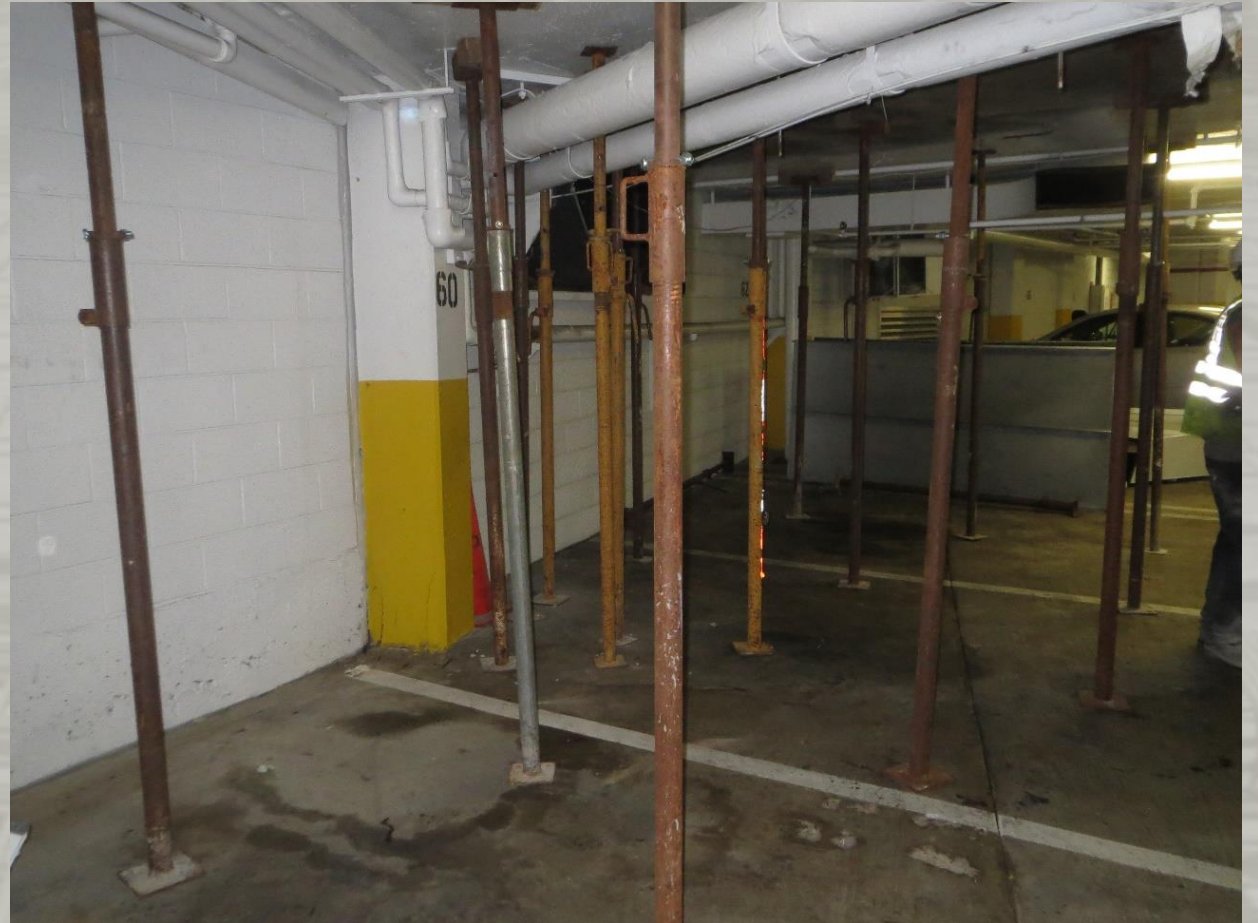
Shore to Ensure Safety to Workers and Public

- Shoring may or may not be required.

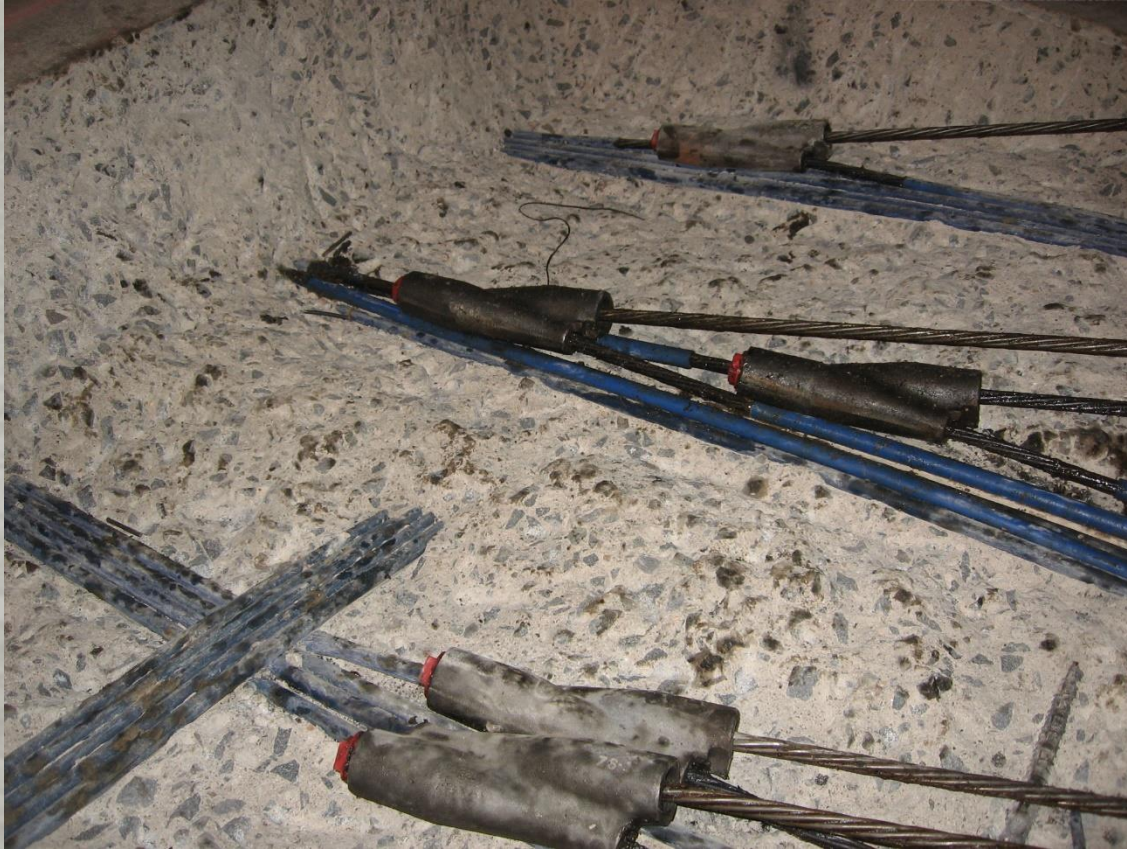
Center Stressing Anchor (Lok Coupler)

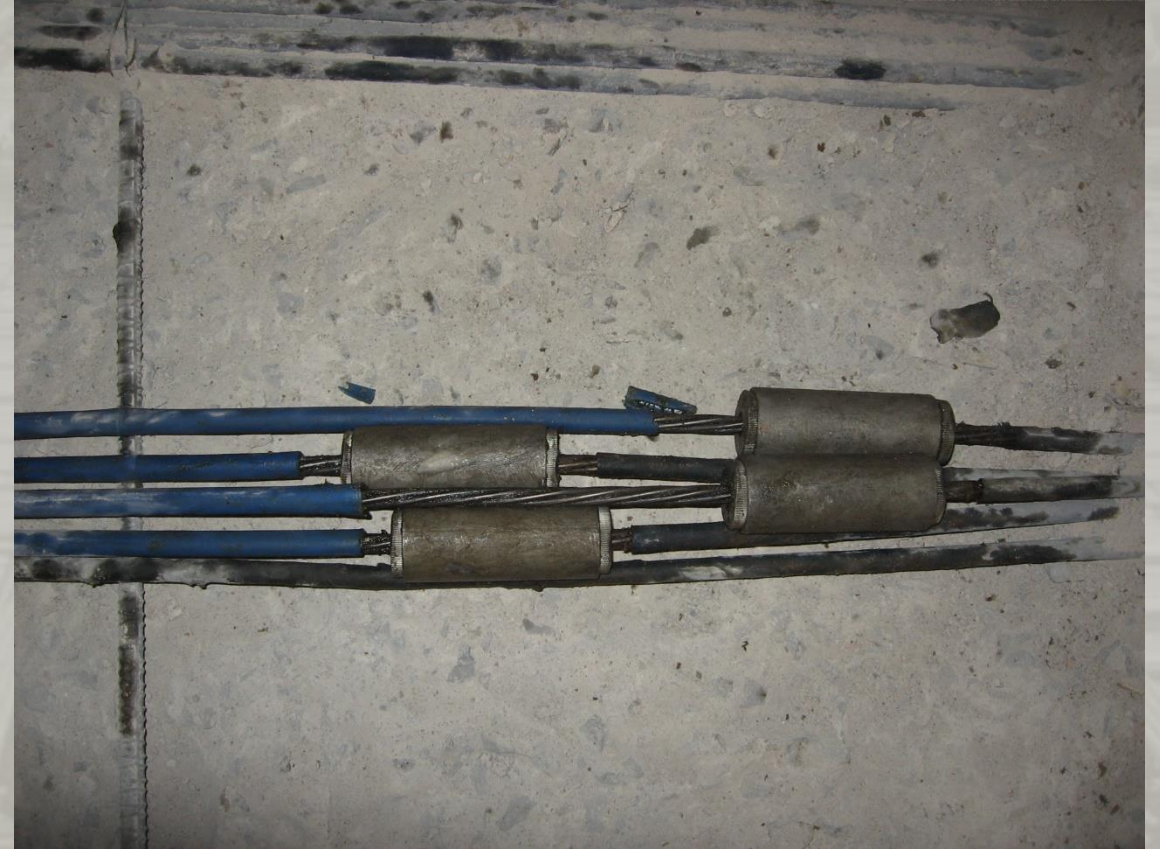
Internal Splice (Splice Chuck)

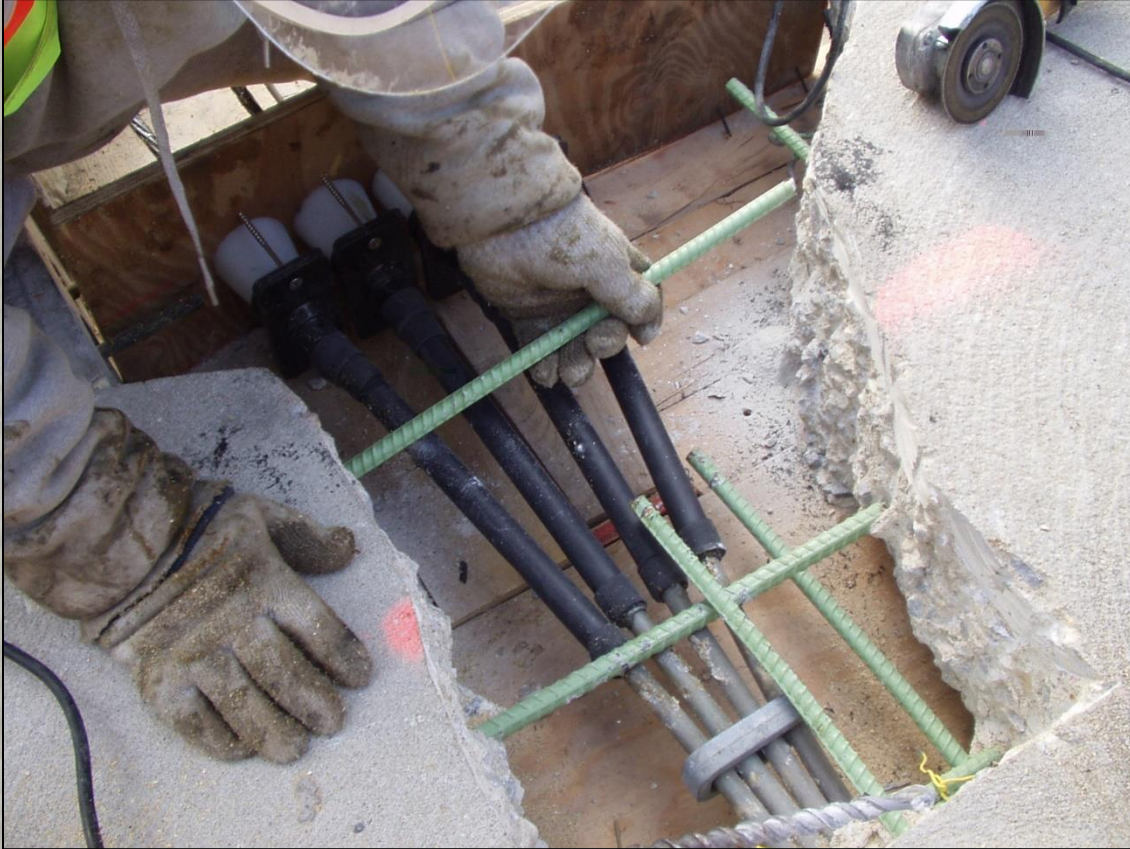
Anchorage Repairs

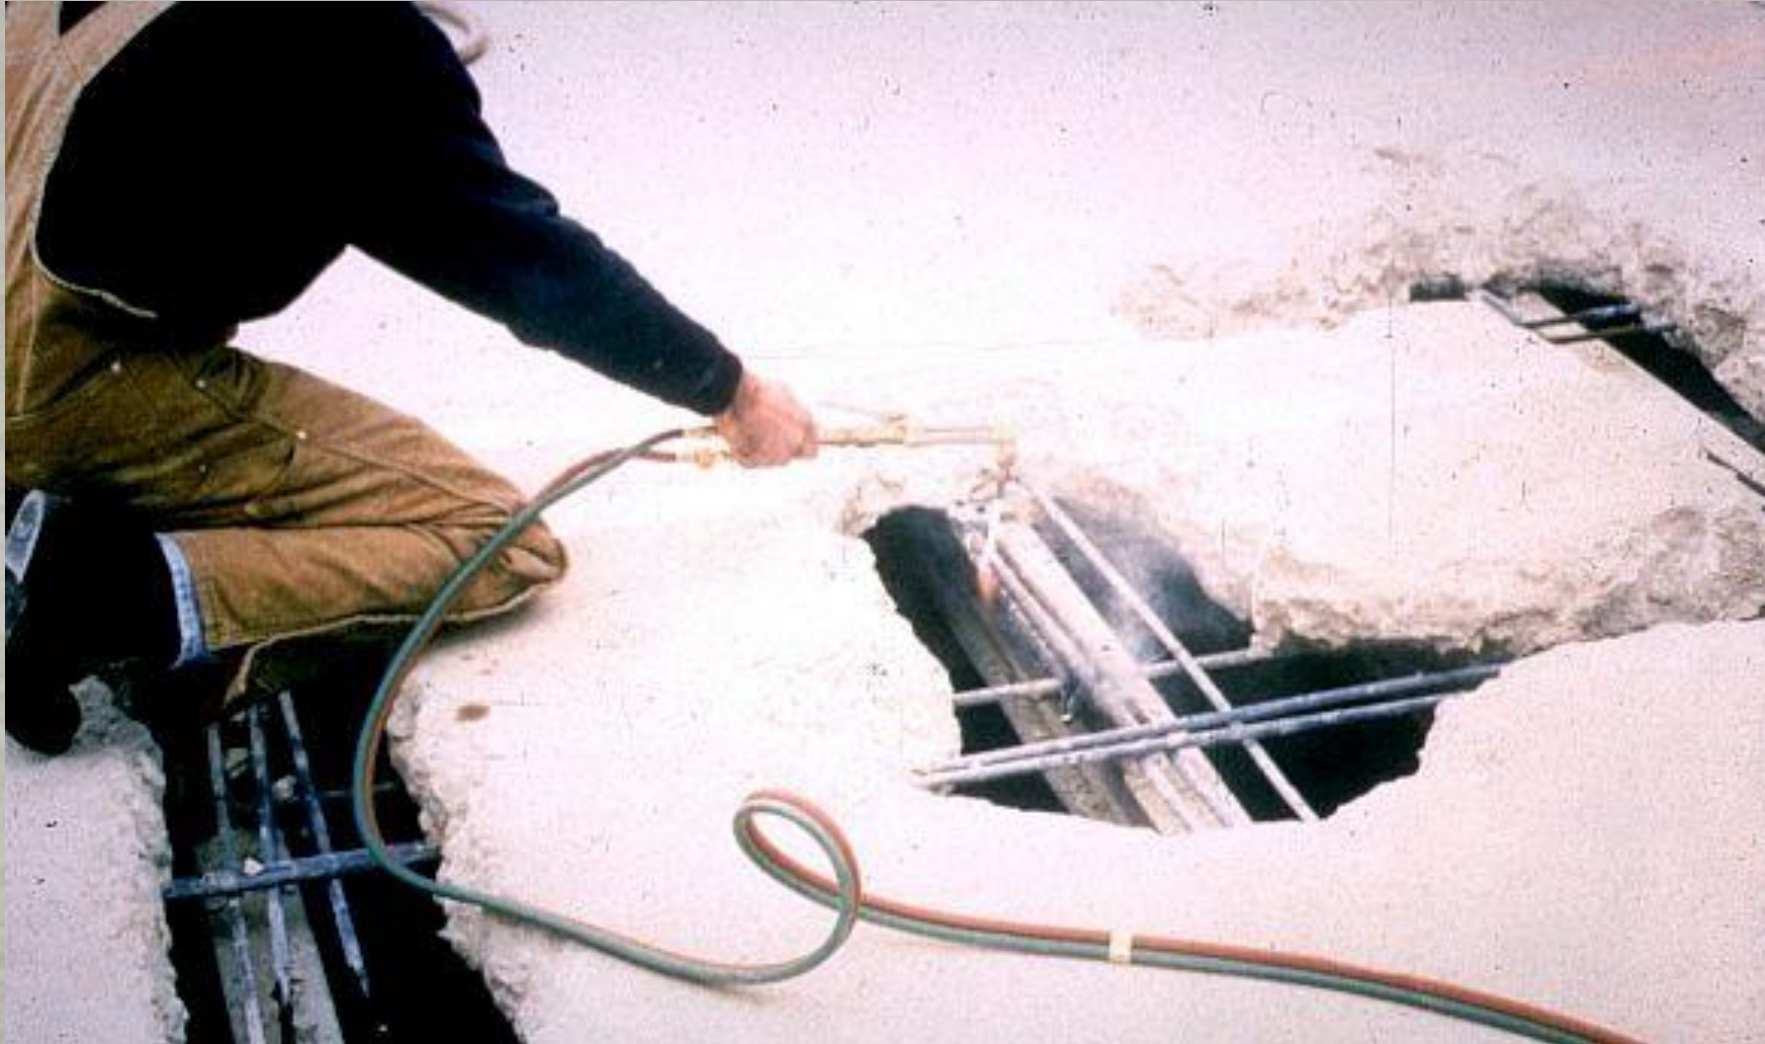
De-Tensioning

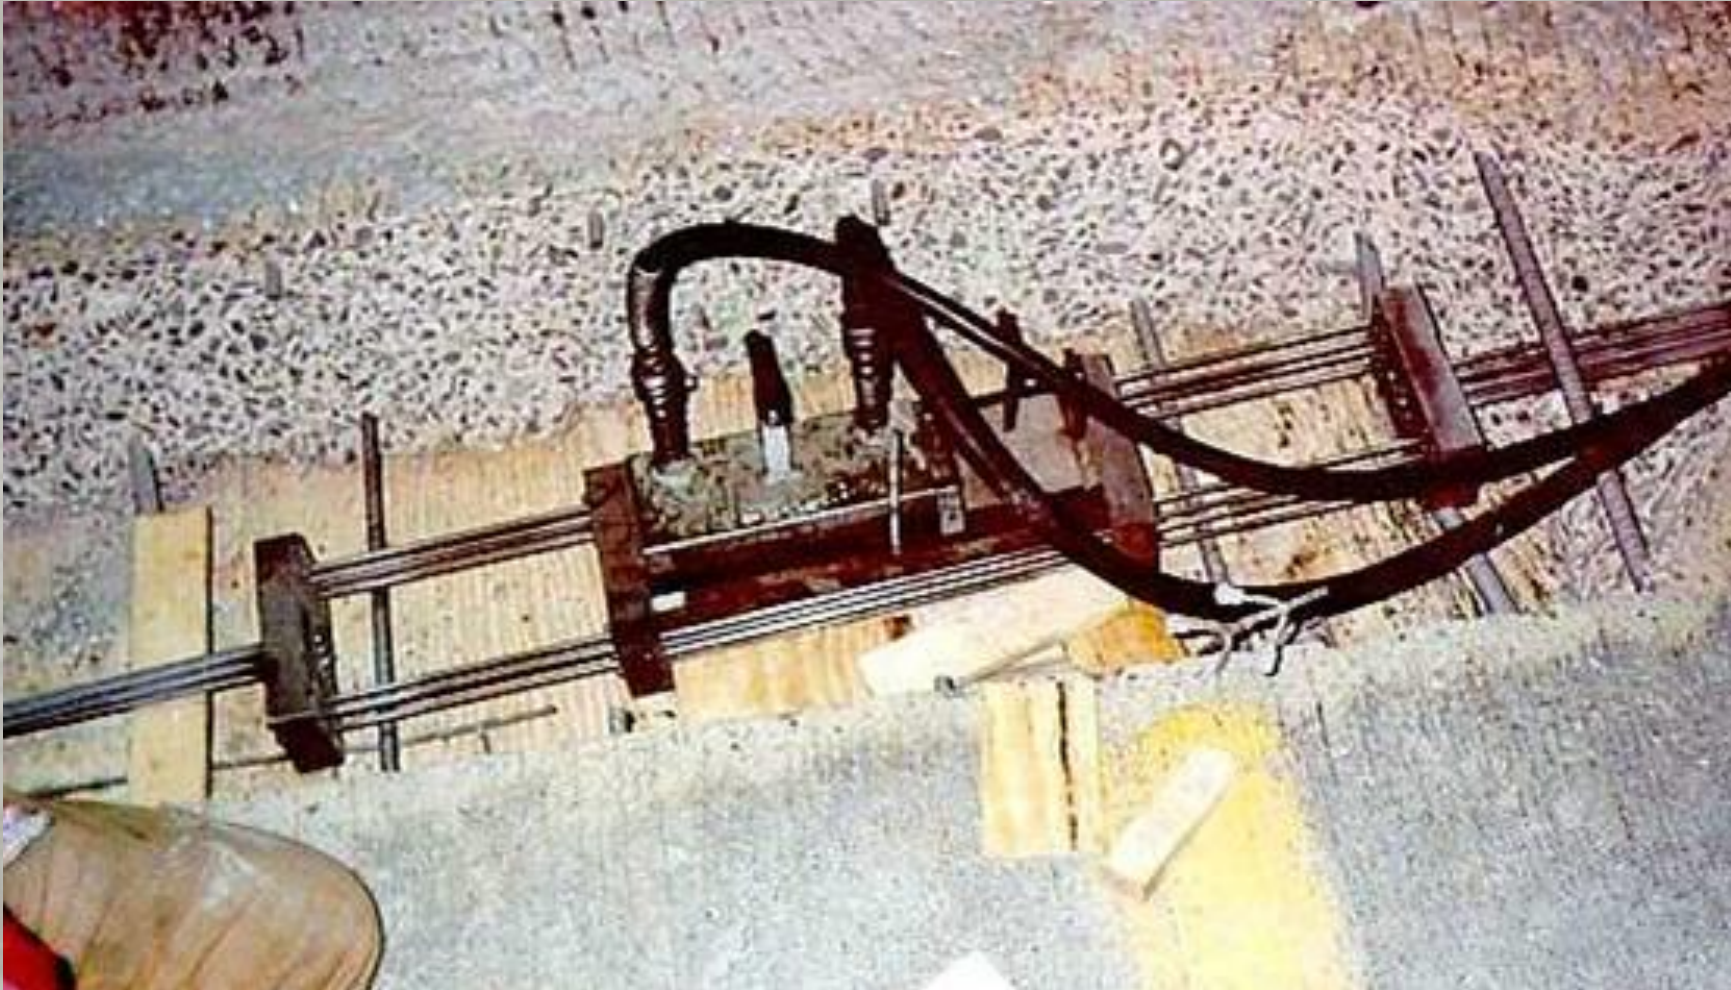
Buttonhead Y-Splice Stressing

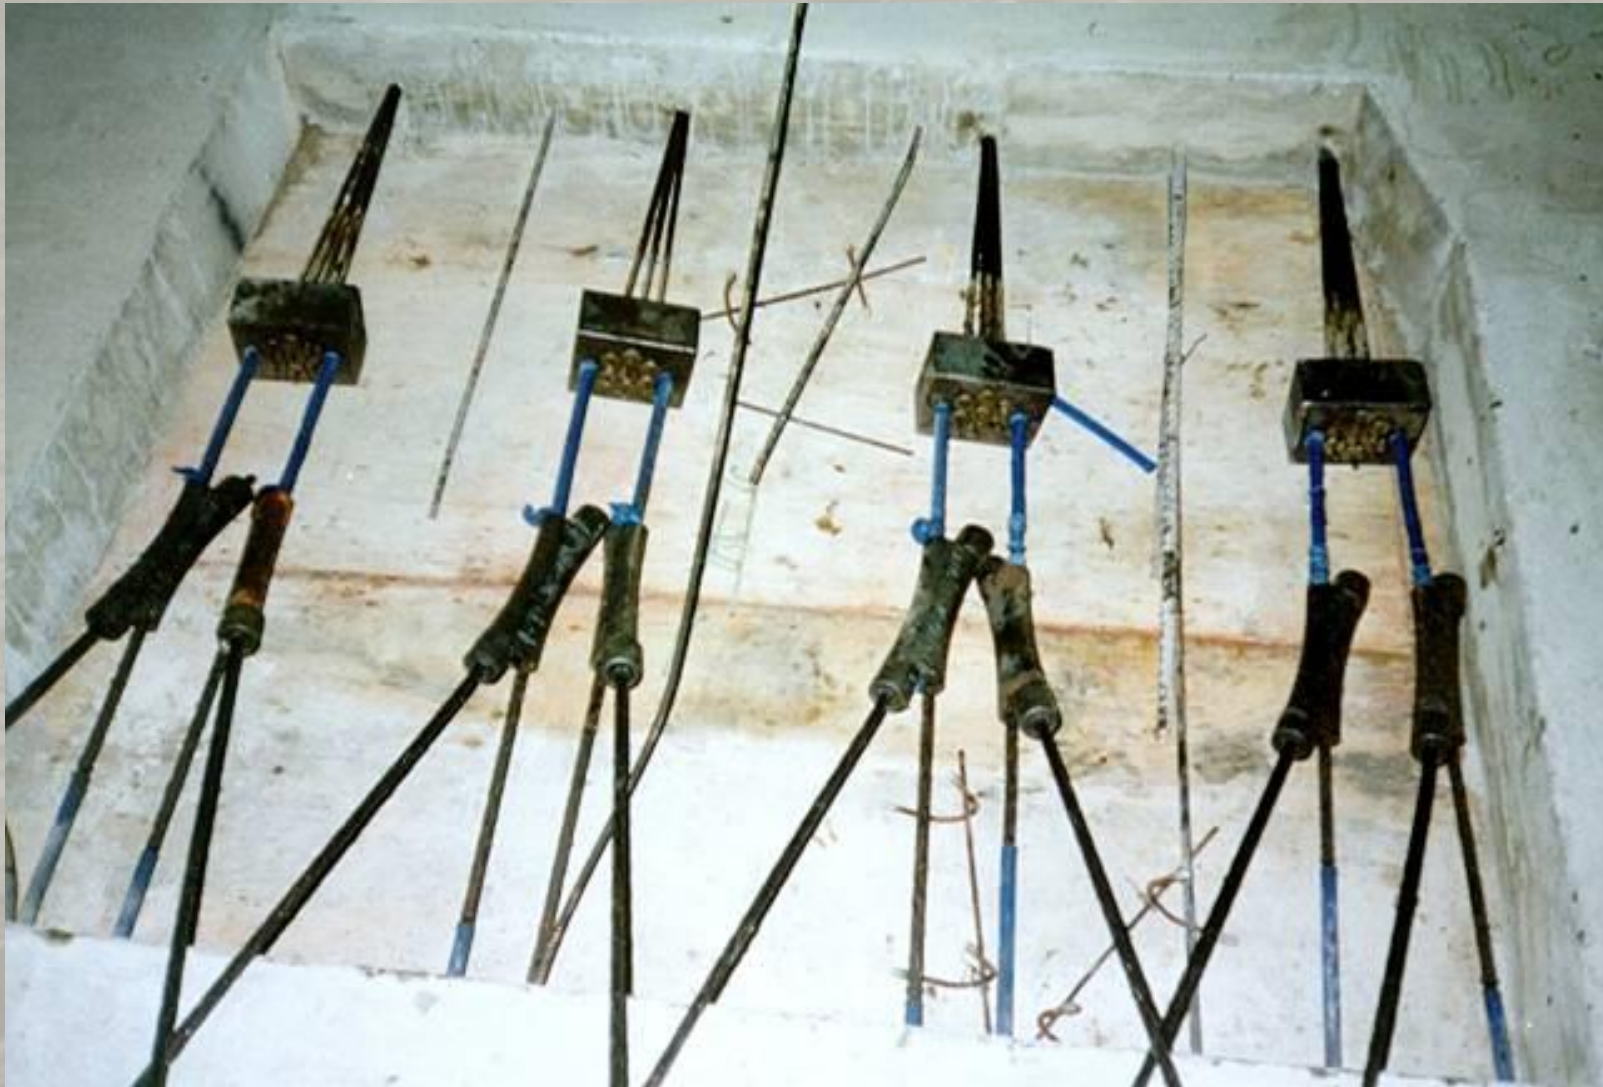
Buttonhead Wire / Monostrand Repair

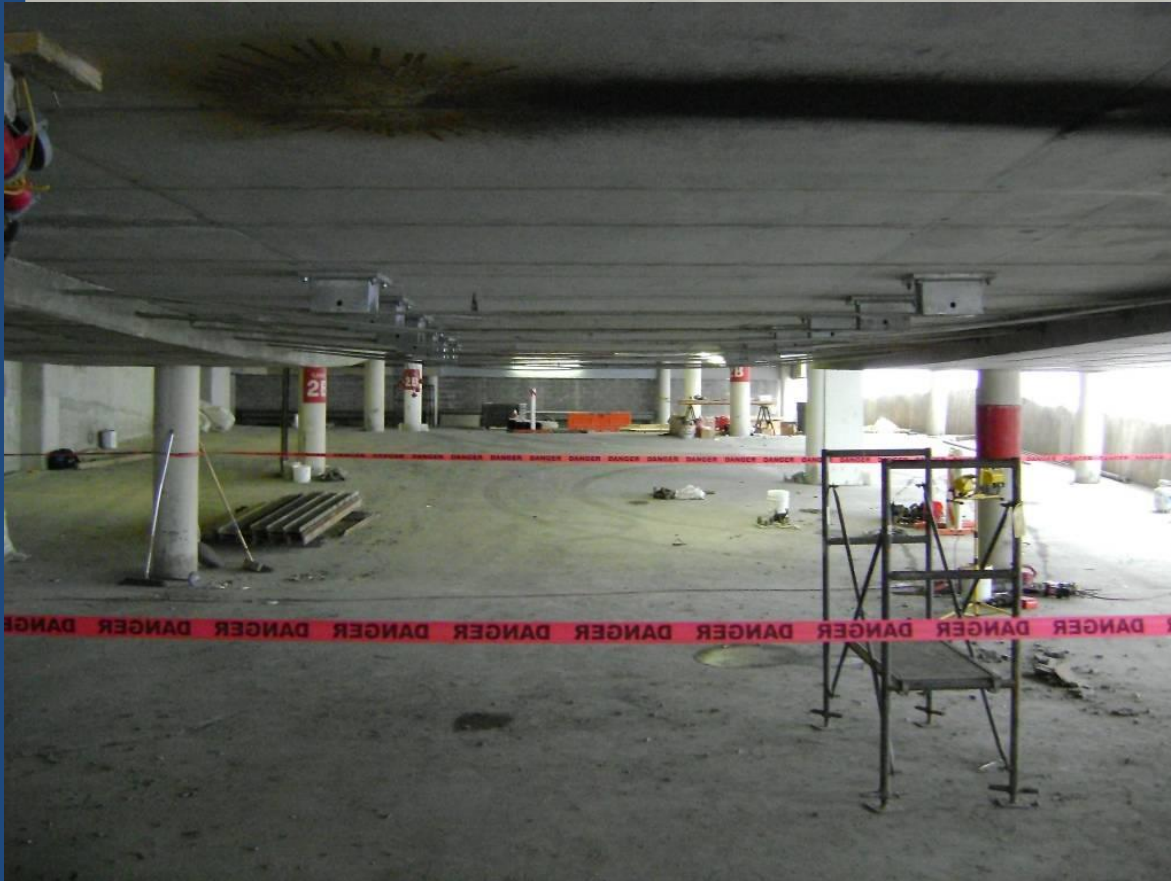
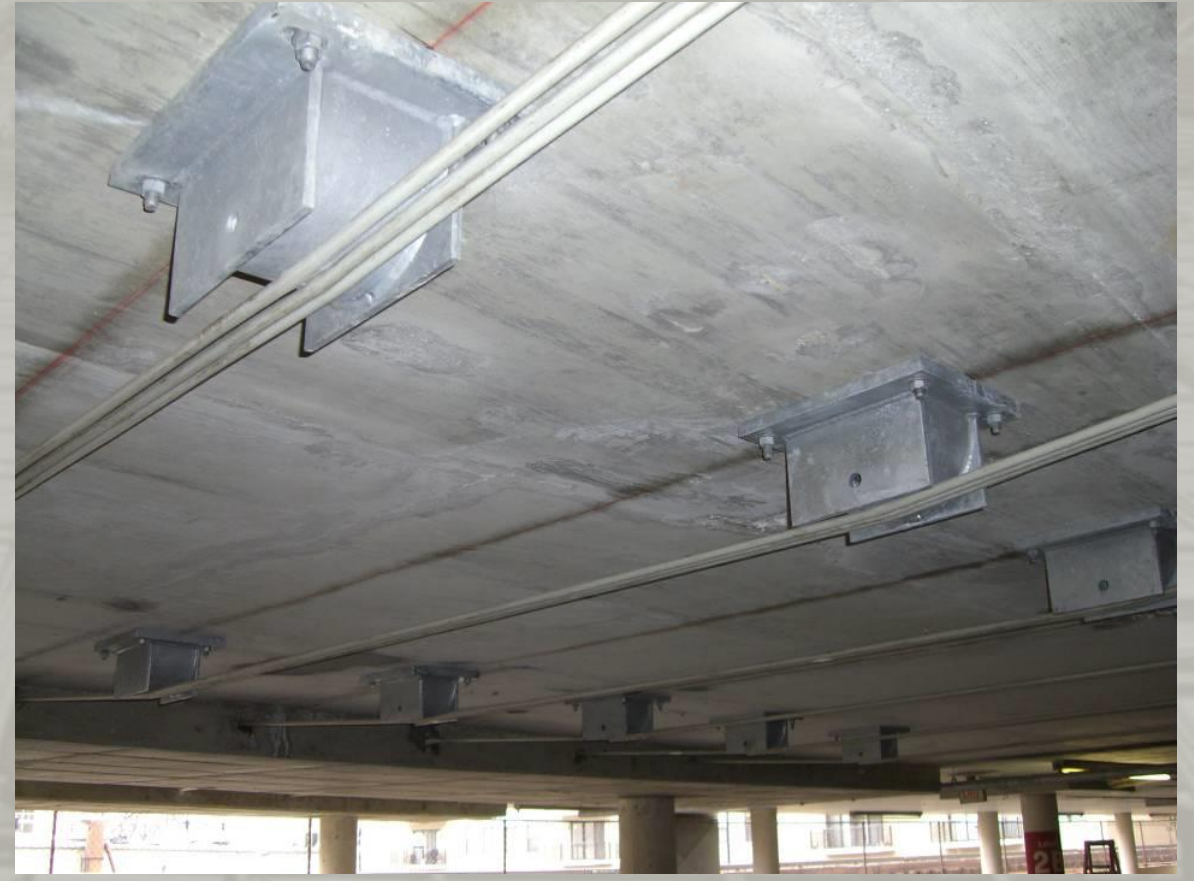
External Post-Tensioning

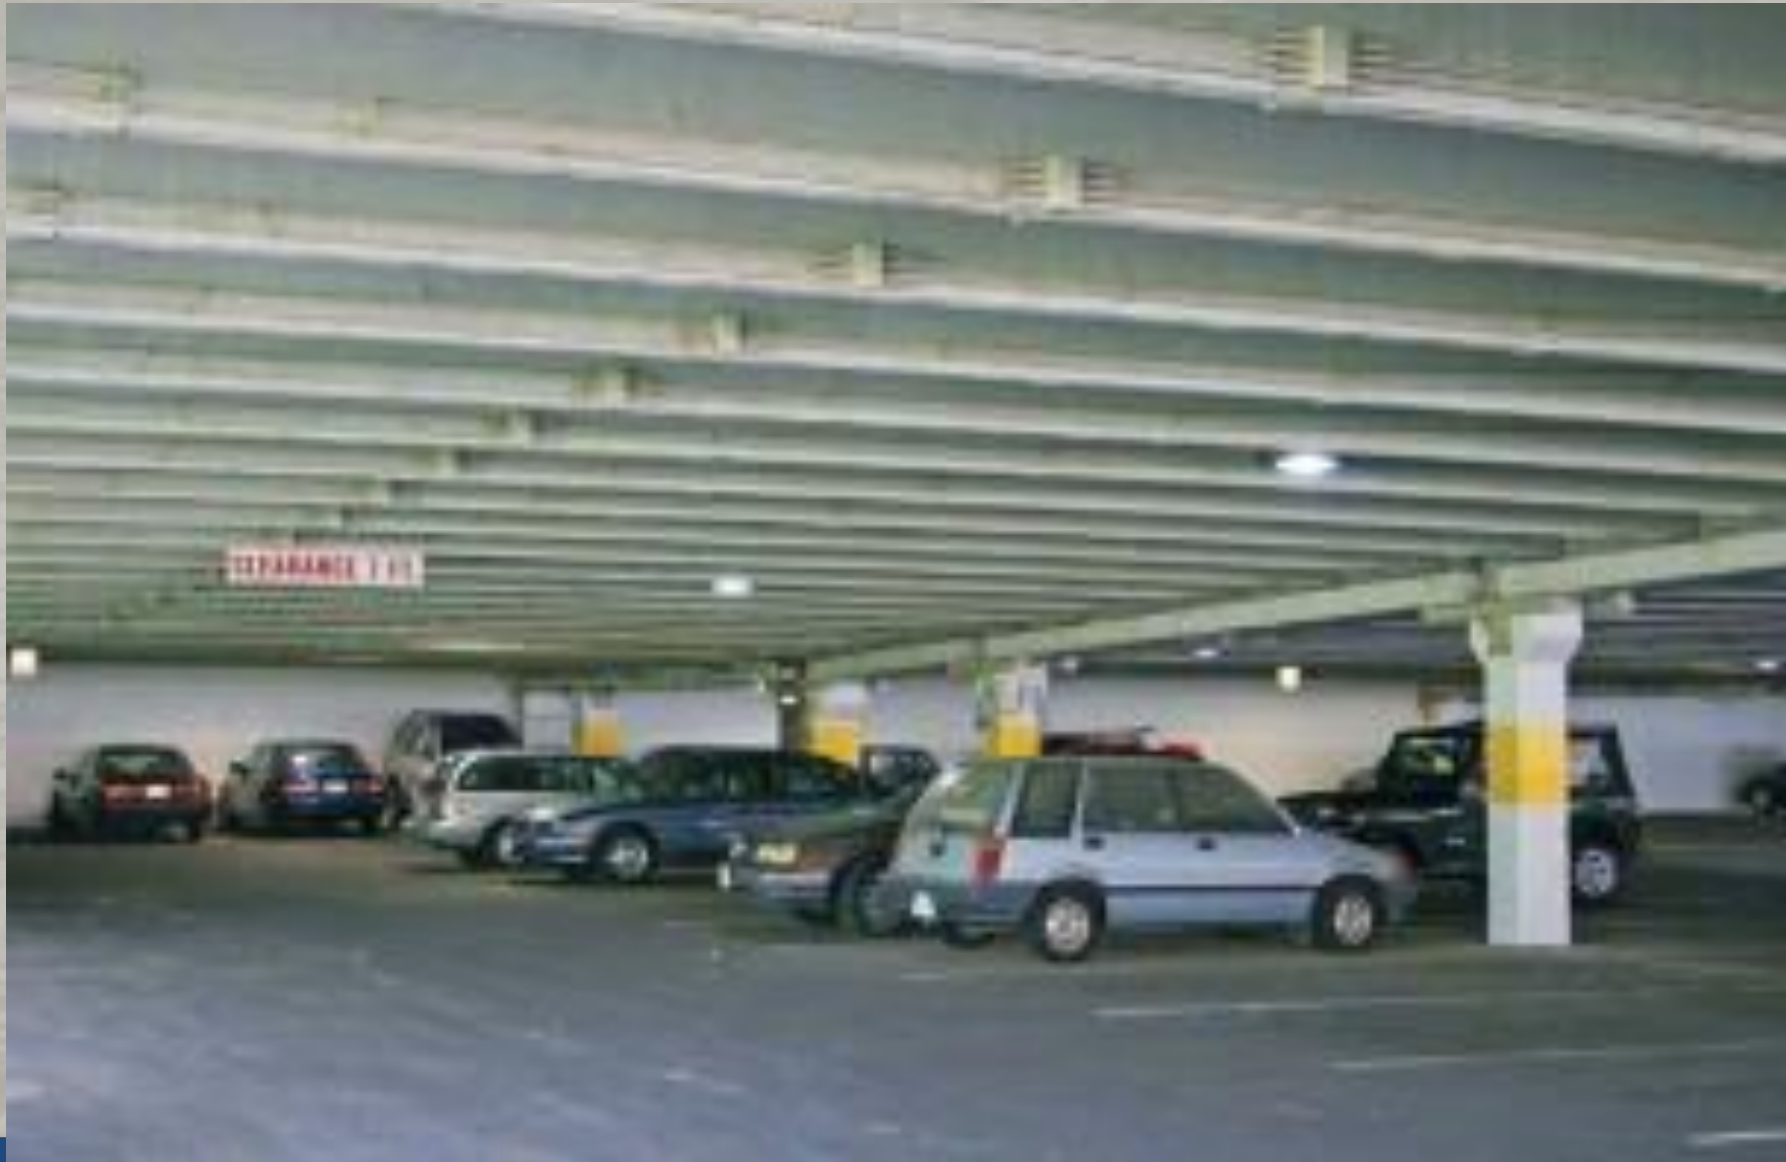
External Post-Tensioning

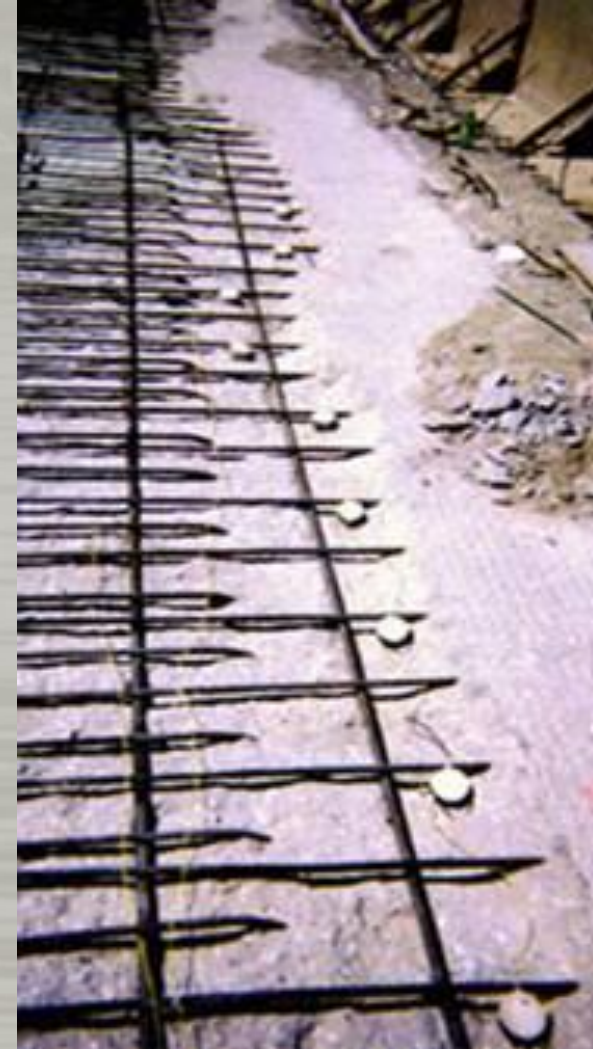
Waterproofing and Protection Strategies

- Sacrificial Anode Cathodic Protection
- Impressed Current Cathodic Protection
